HYUNDAI Technical Service Bulletin

Group	CHASSIS
Number	06-50-005
Date	MARCH, 2006
Model	2006 SONATA

Subject
ALUMINUM WHEEL CAP REPLACEMENT

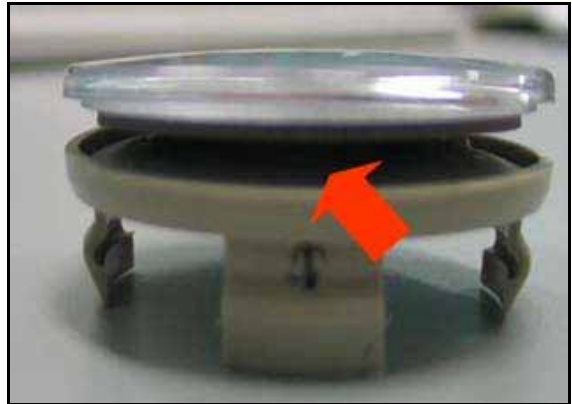
The aluminum wheel cap acrylic "H" logo may separate when exposed to elevated temperatures. If this occurs on a vehicle, replace all four wheel caps at the same time.
