# HYUNDAI Technical Service Bulletin

Group CLIMATE CONTROL
Number 06-97-001
Date APRIL, 2006
Model 2006 AZERA, SONATA

Subject  
**2006 AZERA / SONATA AMBIENT TEMPERATURE SENSOR REPLACEMENT**

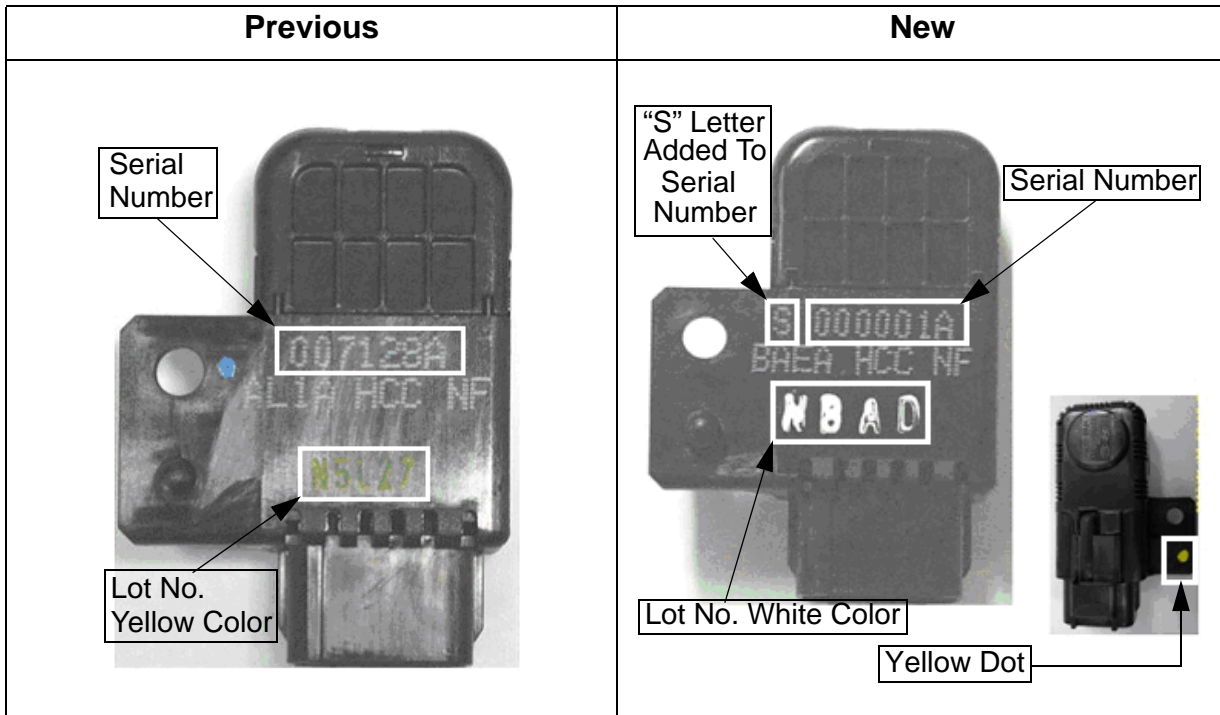
- To determine if the vehicle has a factory installed or an updated part refer to the photos below.
