# HYUNDAI Technical Service Bulletin

Group	TRANSAXLE
Number	07-40-016
Date	NOVEMBER, 2007
Model	1999~ SONATA, 2001~ ELANTRA, SANTA FE & XG, 2003~ TIBURON, 2005~TUCSON, 2006~ AZERA, 2007~ ENTOURAGE

**AUTOMATIC TRANSAXLE DIAGNOSTIC TROUBLE CODES P0715, P0716, P0717, P0720, P0721 & P0722**

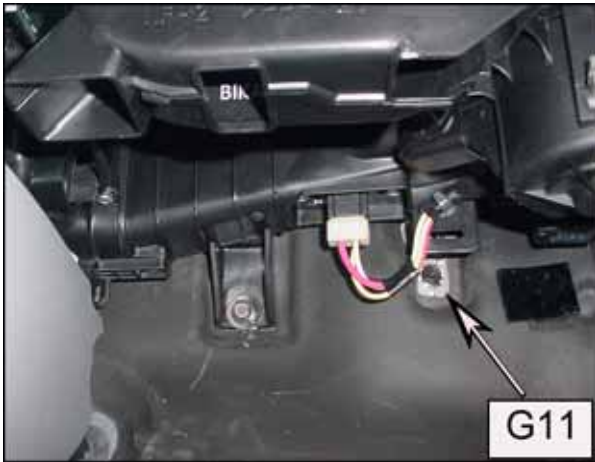
**2006~ SONATA 2.4L & 3.3L**

3. Check the wiring harness visually for an open circuit or short circuit to ground. Check for a pinched harness at the ECU attachment bolts.
4. Disconnect the connectors at the input and output speed sensor and PCM/TCM and check for bent pins or pins not fully inserted into the connector. Check the pin tension using the J-35616-C Pin Tension Tester.
5. If a harness open/short is found, repair or replace the ECM control harness between the PCM/TCM and transaxle and go to Step 8. If not, go to Step 6.
6. **P0722 ONLY:** For 2006~ Sonata and 2007~ Santa Fe vehicles, check the ground bolt located under the passenger side dash. Confirm the bolt is clean and tight.
