HYUNDAI Technical Service Bulletin

Group	TRANSAXLE
Number	07-40-010
Date	AUGUST, 2007
Model	1999~ SONATA, 2001~06 ELANTRA, 2001~ SANTA FE & XG, 2003~ TIBURON, 2005~ TUCSON, 2006~ AZERA, 2007~ ENTOURAGE

AUTOMATIC TRANSAXLE HARSH AND/OR DELAYED UPSHIFT OR DOWNSHIFT - GDS ANALYSIS

This TSB supersedes TSB 07-40-019 to use GDS to analyze shift performance.

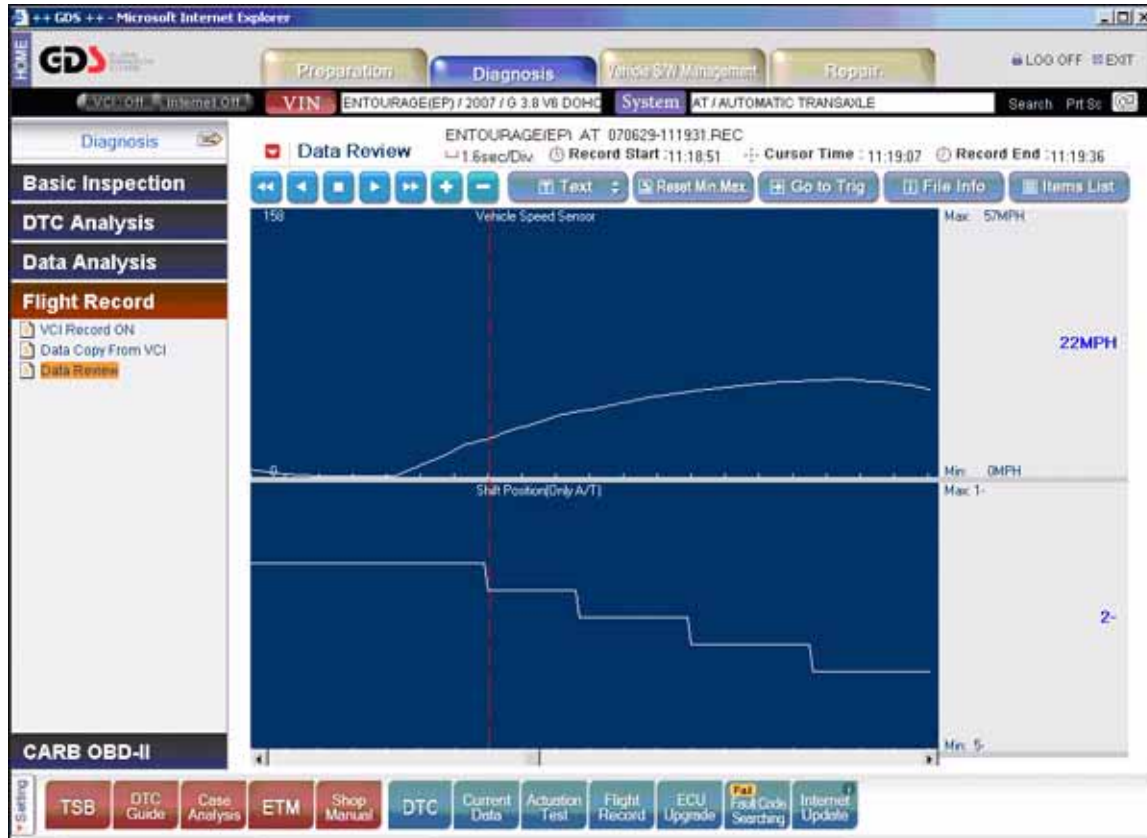
UPSHIFT COMMANDS FROM PCM OR TCM:

Confirm the PCM or TCM commanded each gear: 1, 2, 3, 4 and 5 (if equipped):

- If so, go to pages 3~6 and evaluate the upshift diagnosis for the related shift.
- If not, exchange a PCM or TCM from a properly operating vehicle and test again to determine if the PCM or TCM commanded each gear:
 - If the condition is improved, replace the PCM or TCM
 - If the condition is not improved, go to page 3~6 and evaluate the upshift performance.

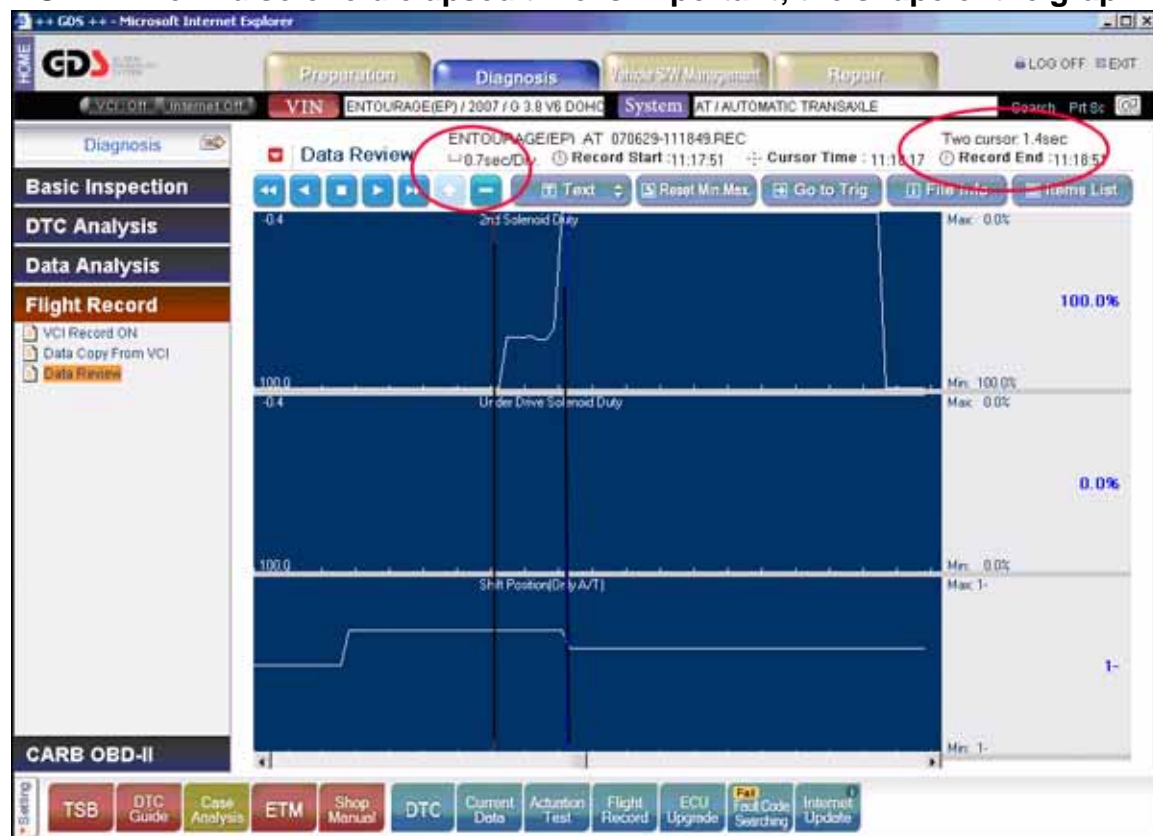
1-2 UPSHIFT DIAGNOSIS:

NOTE: The 2nd solenoid elapsed time is important; the shape of the graph is not.

- Select "Items List" (top right of screen) and select: "2nd Solenoid Duty", "Underdrive Solenoid Duty" and "Shift Position".
- Click the "+" or "-" buttons to choose 0.7 sec./Div or less.
- Move the cursor to the start of the shift and "Left click".
- Move the cursor to the end of the shift and "Right click".
- Read the 2nd solenoid elapsed time at the top right of the screen. If the 1-2 shift requires more than 2.0 seconds, exchange a PCM or TCM from a properly operating vehicle and follow TSB 06-40-005, "Reset and Relearn Adaptive Values":
 - If the condition is improved, replace the PCM or TCM
 - If the condition is not improved, replace the transaxle.

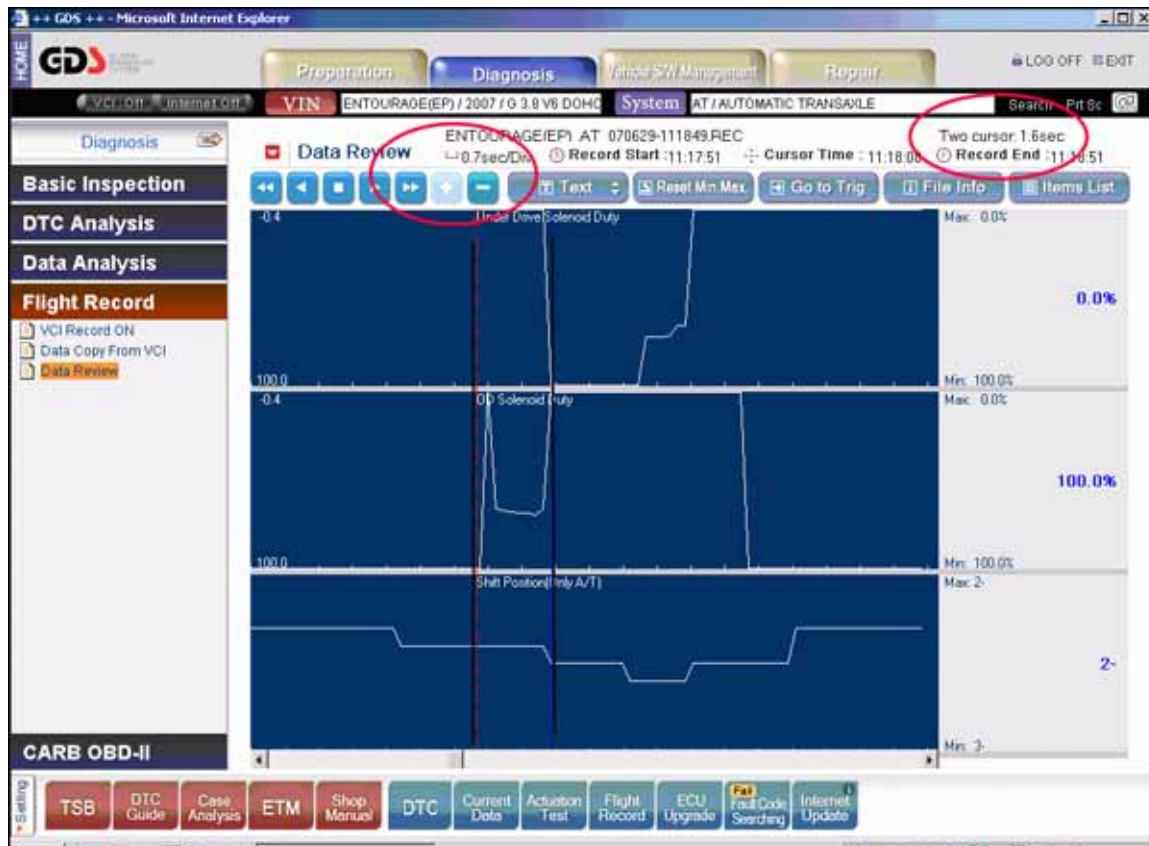
2-3 UPSHIFT DIAGNOSIS:

NOTE: The OD solenoid elapsed time is important; the shape of the graph is not.

- Select "Items List" (top right of screen) and select: "Underdrive Solenoid Duty", "Overdrive Solenoid Duty" and "Shift Position".
- Select the "+" or "-" button to choose 0.7 sec./Div or less.
- Move the cursor to the start of the shift and "Left click".
- Move the cursor to the end of the shift and "Right click".
- Read the OD solenoid elapsed time at the top right of the screen. If the 2-3 shift requires more than 2.0 seconds, exchange a PCM or TCM from a properly operating vehicle and follow TSB 06-40-005, "Reset and Relearn Adaptive Values":
 - If the condition is improved, replace the PCM or TCM
 - If the condition is not improved, replace the transaxle.

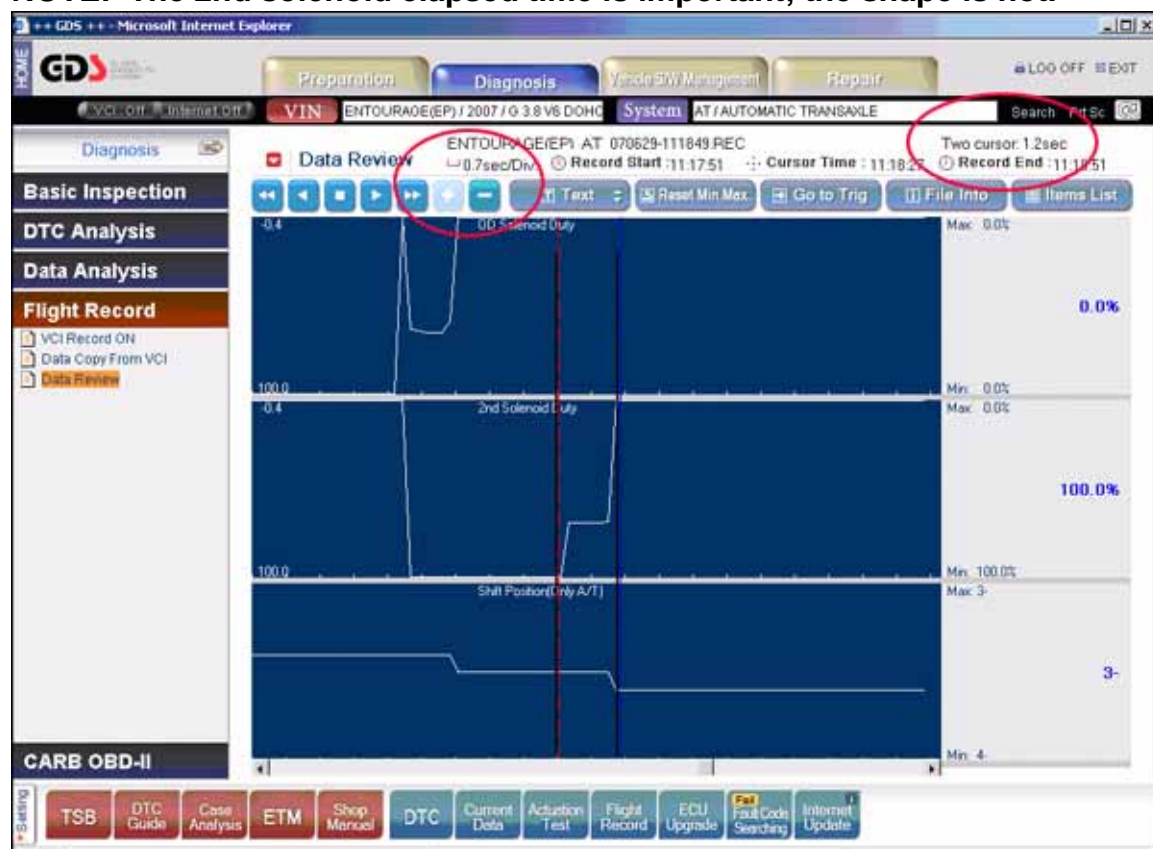
3-4 UPSHIFT DIAGNOSIS:

NOTE: The 2nd solenoid elapsed time is important; the shape is not.

- Select "Items List" (top right of screen) and select: "2nd Solenoid Duty", "Overdrive Solenoid Duty" and "Shift Position".
- Select the "+" or "-" button to choose 0.7 sec./Div or less.
- Move the cursor to the start of the shift and "Left click".
- Move the cursor to the end of the shift and "Right click".
- Read the 2nd solenoid elapsed time at the top right of the screen. If the 3-4 shift requires more than 2.0 seconds, exchange a PCM or TCM from a properly operating vehicle and follow TSB 06-40-005, "Reset and Relearn Adaptive Values":
 - If the condition is improved, replace the PCM or TCM
 - If the condition is not improved, replace the transaxle.

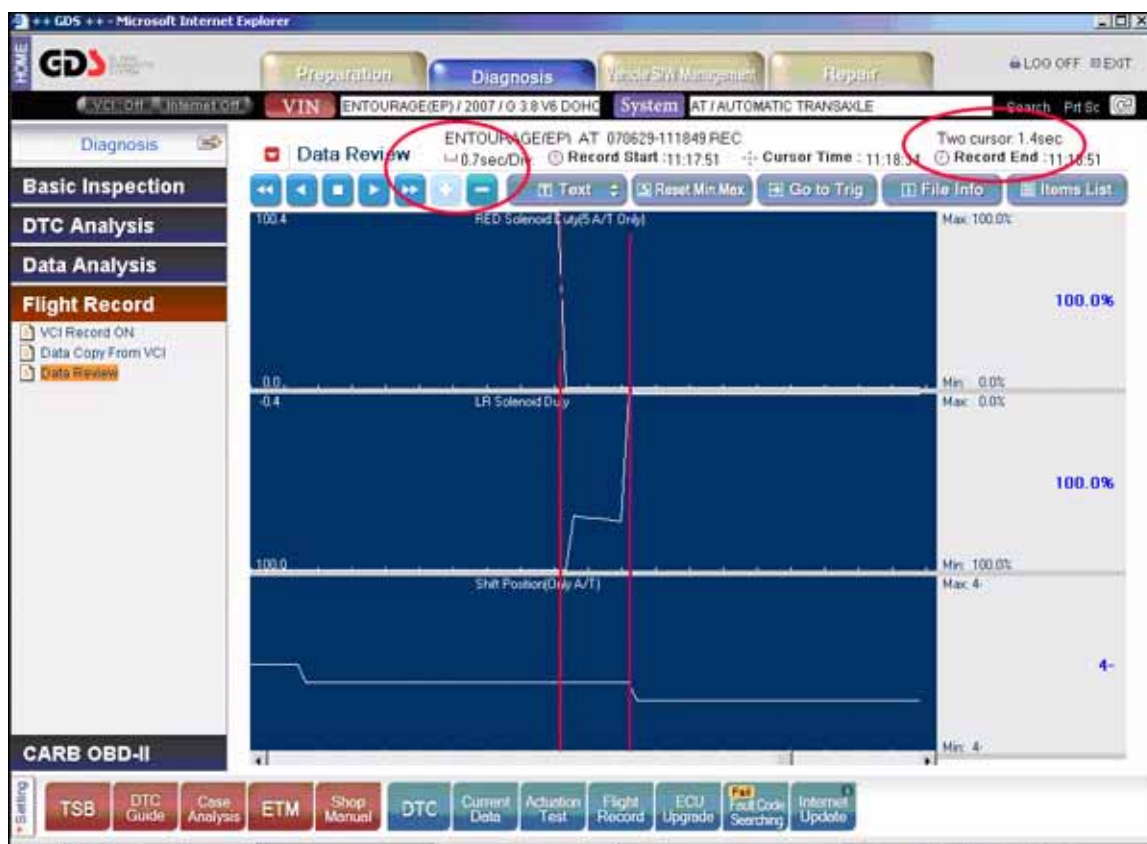
4-5 UPSHIFT DIAGNOSIS:

NOTE: The LR solenoid elapsed time is important; the shape of the graph is not.

- Select “Items List” (top right of screen) and select: “Reduction Solenoid Duty”, Low-Reverse Solenoid Duty and “Shift Position”.
- Select the “+” or “-” button to choose 0.7 sec./Div or less.
- Move the cursor to the start of the shift and “Left click”.
- Move the cursor to the end of the shift and “Right click”.
- Read the LR solenoid elapsed time at the top right of the screen. If the 4-5 shift requires more than 2.0 seconds, exchange a PCM or TCM from a properly operating vehicle and follow TSB 06-40-005, “Reset and Relearn Adaptive Values”:
 - If the condition is improved, replace the PCM or TCM
 - If the condition is not improved, replace the transaxle.
