# HYUNDAI Technical Service Bulletin

Group	CHASSIS
		Number	05-50-012
Subject  <b>DIAGNOSIS AND CORRECTION OF VEHICLE PULL</b>		Date	NOVEMBER, 2005
		Model	ALL
<b>CIRCULATE TO:</b>	<input type="checkbox"/> GENERAL MANAGER	<input checked="" type="checkbox"/> PARTS MANAGER	<input checked="" type="checkbox"/> TECHNICIAN
<input checked="" type="checkbox"/> SERVICE ADVISOR	<input checked="" type="checkbox"/> SERVICE MANAGER	<input checked="" type="checkbox"/> WARRANTY MGR	<input type="checkbox"/> SALES MANAGER

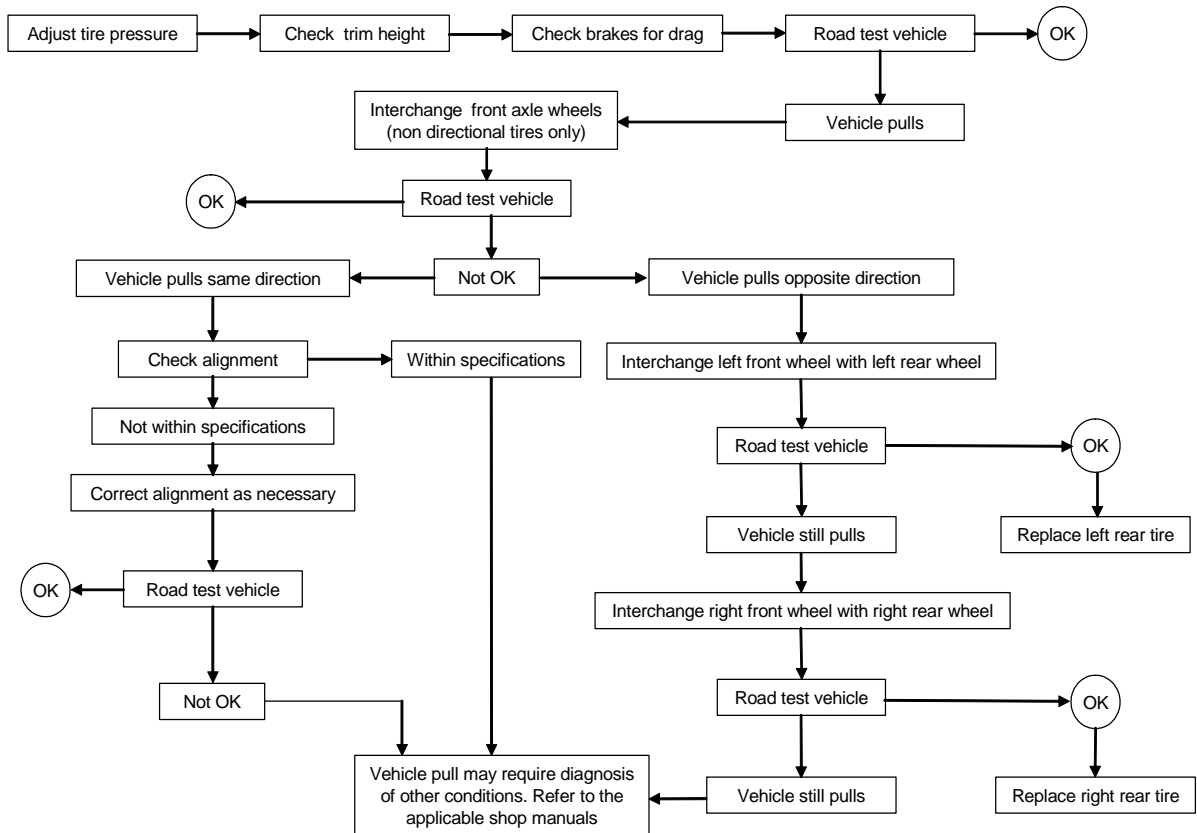
## FLOW CHART FOR CORRECTING VEHICLE PULL CONDITION

- Tire construction - The way in which the tire is built can produce vehicle pull. An example of this is the placement of the under tread belt. An off-center radial tire belt can cause the tire to develop a side force while rolling straight down the road and the tire will tend to roll like a cone. To correct this condition, please use the attached flow chart. This chart provides the sequence of procedures designed to be performed for all conditions of vehicle pull.
