# HYUNDAI Technical Service Bulletin

Group	CHASSIS
Number	06-50-009
Date	AUGUST, 2006
Model	SONATA, AZERA

Subject  
**FRONT HUB AND DRIVESHAFT ISOLATION WASHER  
 INSTALLATION PROCEDURE**

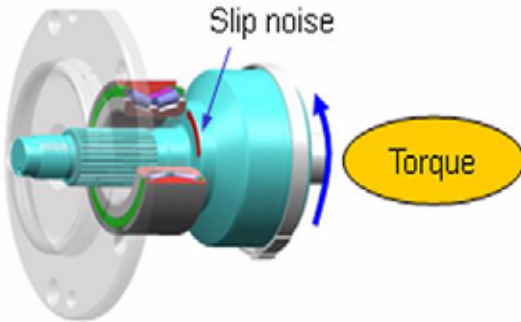
- Symptom/Condition:  
 A "snap" noise caused by surface contact between the front hub and driveshaft may be heard when some SONATA (NF) or AZERA (TG) vehicles are driven forward after being driven in reverse.
- Cause:  
 Slip along the contact surface between the front hub and the driveshaft.

- Service Procedure: Insert the isolation washer between the front hub and driveshaft.
