# HYUNDAI Technical Service Bulletin

Group	CHASSIS
Number	06-50-017
Date	DECEMBER, 2006
Model	AZERA (TG) AND SONATA (NF)

Subject  
**FRONT WHEEL TOE-IN ADJUSTMENT CAUTION**

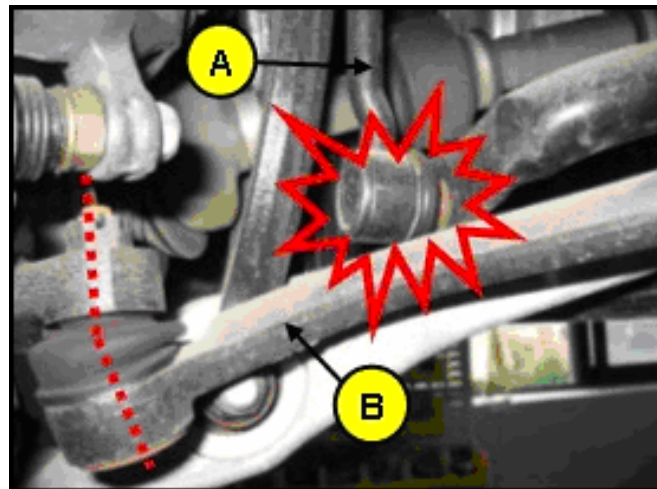
During toe-in adjustment, the tie rod end (B) may move towards the stabilizer bar link (A) and reduce the clearance between the two parts as shown.

**NOTE:** Minimum clearance between the tie rod and the stabilizer bar link may cause an interference noise when the steering is turned fully or the vehicle is driven over uneven or rough road surfaces.
