# HYUNDAI Technical Service Bulletin

Group	TRANSAXLE
Number	07-40-009
Date	AUGUST, 2007
Model	1999~SONATA, 2001~06 ELANTRA, 2001~SANTA FE & XG. 2003~ TIBURON, 2005~ TUCSON, 2006~ AZERA, 2007~ ENTOURAGE

Subject  
**AUTOMATIC TRANSAXLE HARSH AND/OR DELAYED ENGAGEMENT INTO DRIVE OR REVERSE**

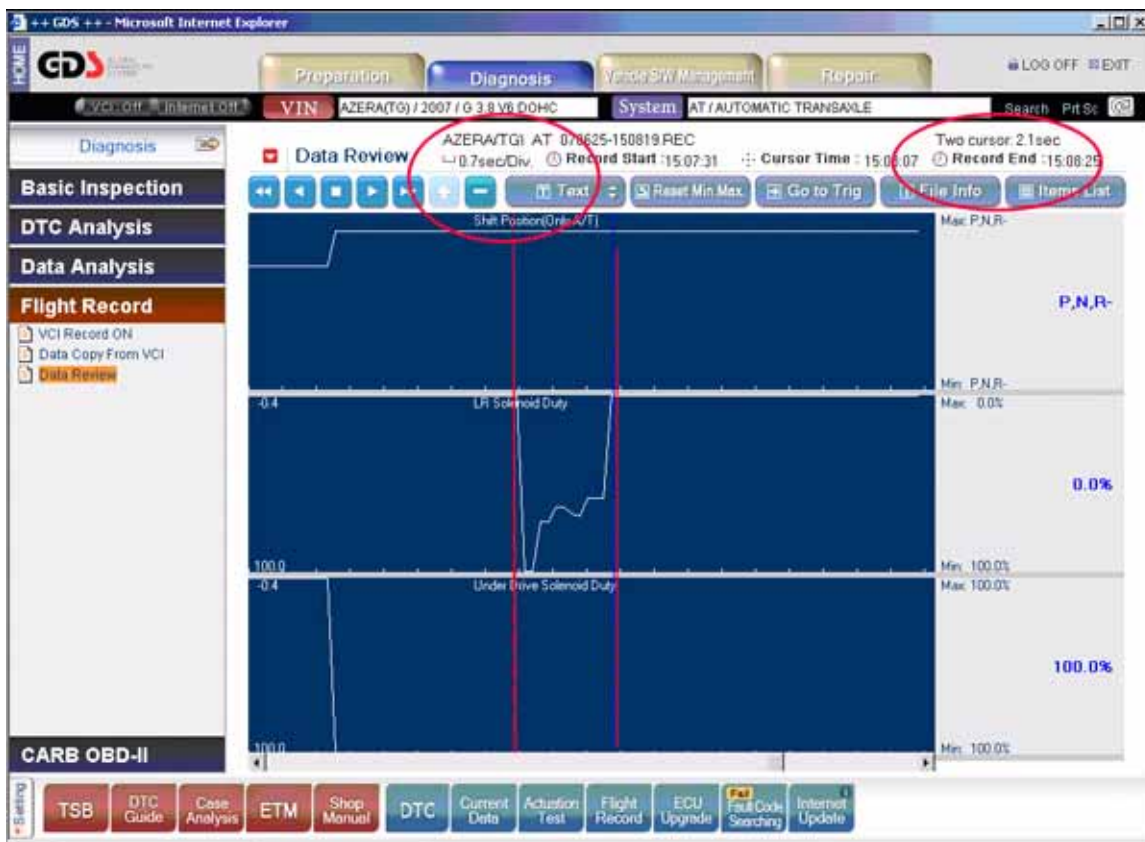
## MEASURE PARK TO REVERSE ENGAGEMENT TIME:

**NOTE: The LR solenoid elapsed time is important; the shape of the graph is not.**

13. Select "Flight Record" and "Data Review", select the vehicle and open the file.
14. Select "Items List" (top right of screen), then select "Shift Position", LR Solenoid Duty" and "Underdrive Solenoid Duty".
15. Click the "+" button to change to "0.7 sec./Div" or smaller"
16. Move the cursor to the start of the shift and "Left click"
17. Move the cursor to the end of the shift and "Right Click".
18. Read the Low & Reverse solenoid engagement time on the top right of the screen. If the P-R shift requires more than 2.2 seconds, exchange a PCM or TCM from a properly operating vehicle and follow TSB 06-40-005, "Reset and Relearn Adaptive Values":
  - If the condition is improved, replace the PCM or TCM
  - If the condition is not improved, replace the transaxle.

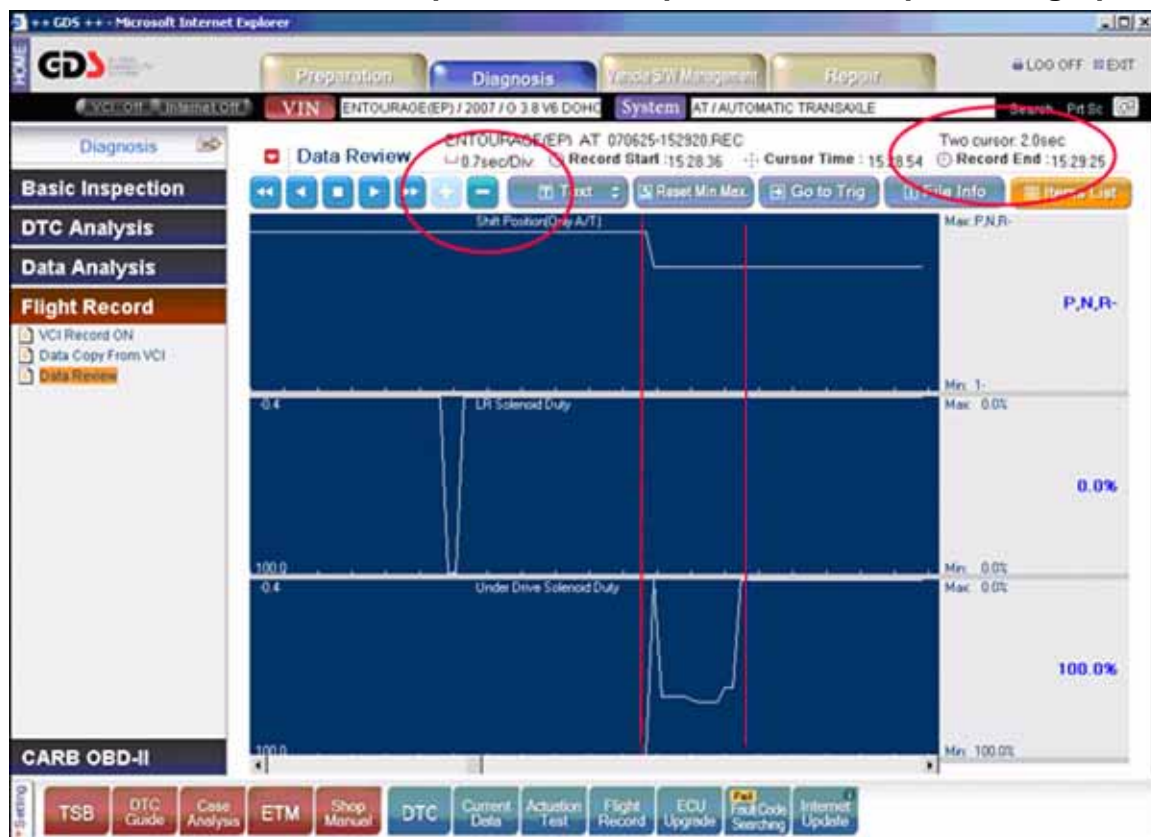
## MEASURE PARK TO DRIVE ENGAGEMENT TIME:

**NOTE: The UD solenoid elapsed time is important; the shape of the graph is not.**

19. Select "Flight Record" and "Data Review", select the vehicle and open the file.
20. Select "Items List" (top right of screen), then select "Shift Position", LR Solenoid Duty" and "Underdrive Solenoid Duty".
21. Click the "+" button to change to "0.7 sec./Div" or smaller"
22. Move the cursor to the start of the shift and "Left click"
23. Move the cursor to the end of the shift and "Right Click".
24. Read the UD engagement time on the top right of the screen. If the P-D shift requires more than 2.2 seconds, exchange a PCM or TCM from a properly operating vehicle and follow TSB 06-40-005, "Reset and Relearn Adaptive Values":
  - If the condition is improved, replace the PCM or TCM
  - If the condition is not improved, replace the transaxle.
