HYUNDAI Technical Service Bulletin

| Number | 06-40-010 |
| Model | 2006 AZERA & SONATA 3.3L |

| Subject | NOISE FROM BELLHOUSING |

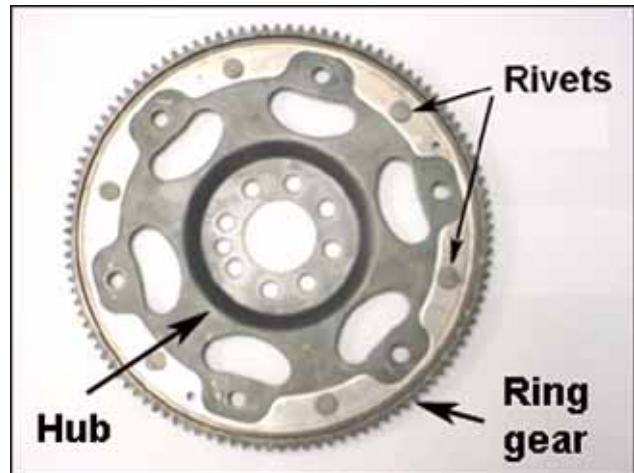
Some 2006 Azera and Sonata 3.3L vehicles may exhibit a rattling or growling noise in the bellhousing area of the automatic transaxle. Please follow the repair procedure shown below to diagnosis this condition.

1. Use a stethoscope to determine the location of the noise. If the noise originates from the bellhousing area and the vehicle is produced prior to May 04, 2006, remove the transaxle.
2. Check if the ring gear can be moved relative to the hub. If so, replace the C.P.S. wheel plate assembly, P/N 23200-3C130.
