HYUNDAI Technical Service Bulletin

Group	TRANSAXLE
Number	06-40-013
Date	SEPTEMBER, 2006
Model	2001~ SANTA FE & XG, 2002~ SONATA, 2003~ TIBURON, 2005~ TUCSON, 2006~ AZERA

Subject
AUTOMATIC TRANSAXLE “SHIFTRONIC” DIAGNOSIS

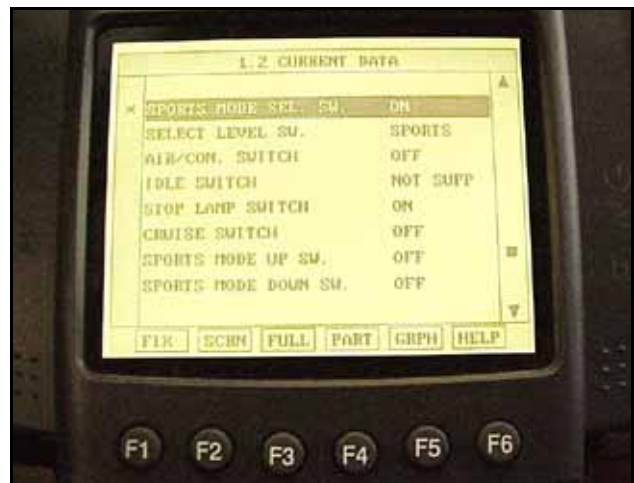
1. SPORTS MODE SELECT SWITCH TEST:

With ignition key “ON” and engine off, select “Sports Mode Select Switch.”

Check the operation of the select switch when the shift lever is moved from “D” to “Sports Mode” and back.

SELECT	NORMAL MODE	SPORTS MODE
Sports Mode Select Switch	OFF	ON

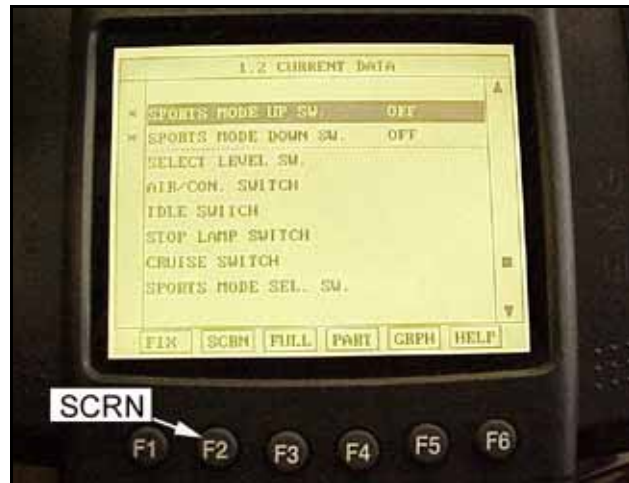
2. SPORTS MODE UPSHIFT & DOWNSHIFT SWITCH TEST:

Shift the Sports Mode lever to the upshift and downshift positions and check the operation of the switches:

SELECT	WHEN UPSHIFTING	WHEN DOWNSHIFTING
Sports Mode Up Switch	ON for about 1 second	OFF
Sports Mode Down Switch	OFF	ON for about 1 second

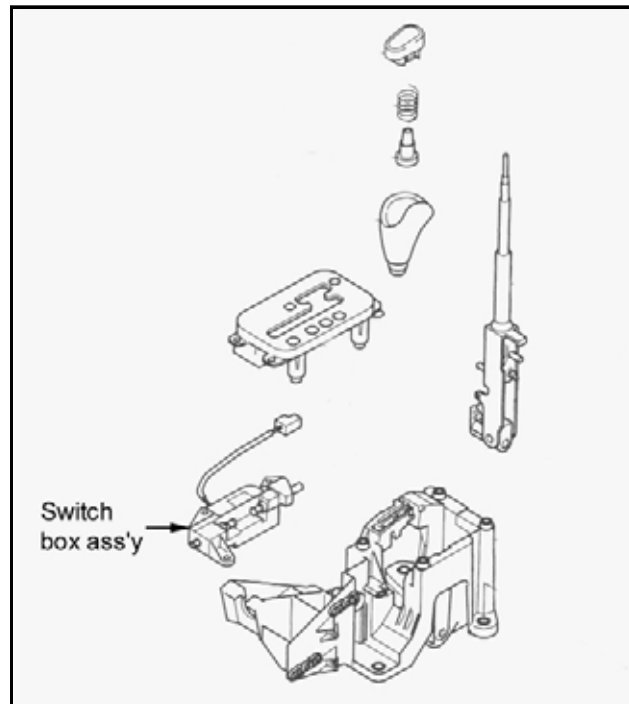
SWITCH BOX REPLACEMENT (2001~SANTA FE & XG, 2002~ SONATA & 2003~TIBURON):

If the switches do not operate as shown above, proceed as follows:

1. Refer to the appropriate shop manual, “Body” section and remove the center console.
2. Check the wiring visually for an open or short circuit. Check related connectors for pins that are bent or not fully inserted. If ok, go to step 3.
3. Refer to the appropriate shop manual, “Automatic Transaxle Control System” section and replace the switch box assembly.

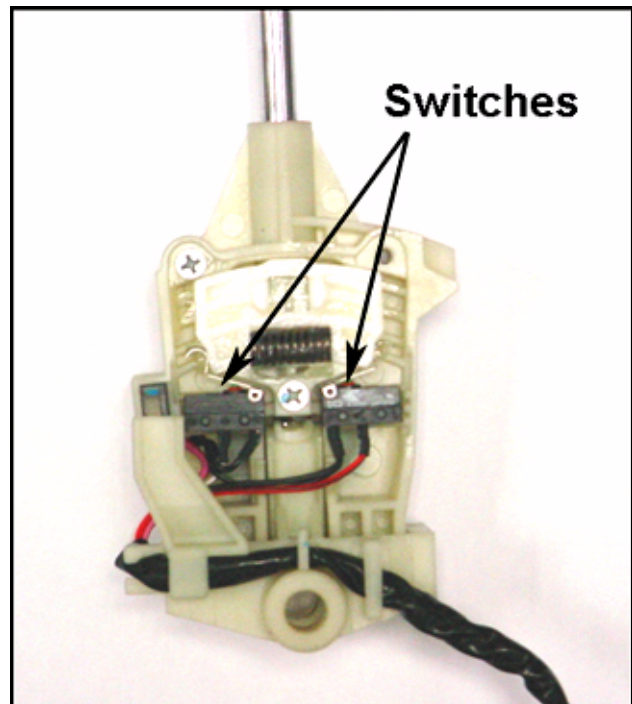
GEAR SHIFT LEVER REPLACEMENT (2006~ SONATA & AZERA, 2007~ SANTA FE):

- Refer to the appropriate shop manual, "Body" section, to remove the center console.
- Check the wiring visually for an open or short circuit. Check related connectors for pins that are bent or not fully inserted. If ok, go to step 3.
- Refer to the appropriate shop manual, "Automatic Transaxle Control System" section and replace the gear shift lever assembly.
