# HYUNDAI Technical Service Bulletin

Group	ENGINE ELECTRICAL
Number	05-36-008
Date	JULY, 2005
Model	2006 SONATA 3.3L

Subject  
**STARTER SHROUD HOLE ON 2006 SONATA WITH 3.3L ENGINE**

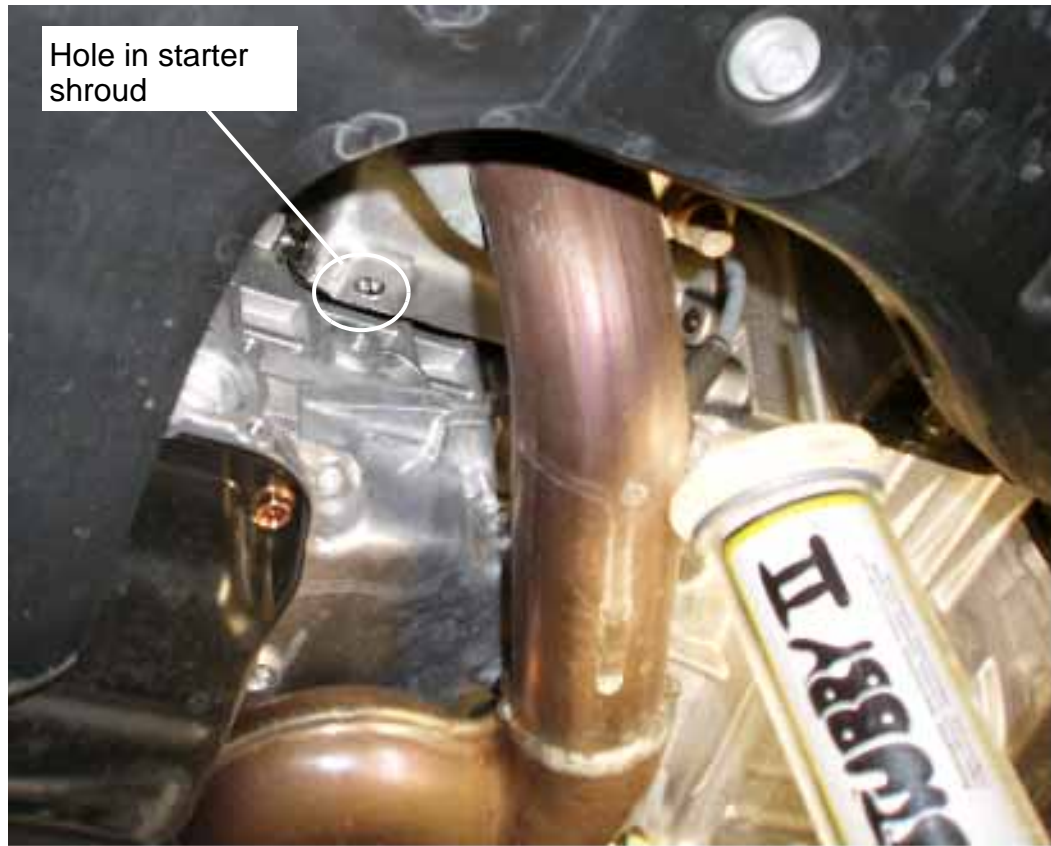
2006 Sonata vehicles equipped with 3.3L V6 engines may have a slotted hole on the bottom surface of the stamped starter shroud just above the engine oil pan near the right front of the vehicle. This condition is normal and it does not affect vehicle operation. No action is required to fill the hole.

**NOTE: DO NOT ATTEMPT TO ADD A BOLT OR OTHER COMPONENT TO FILL THE HOLE.**
