HYUNDAI Technical Service Bulletin

Group	BODY ELECTRICAL
Number	08-BE-006
Date	AUGUST, 2008
Model	SONATA (NF)

Subject
NF XM SET TOP BOX DIAGNOSIS AND REPAIR

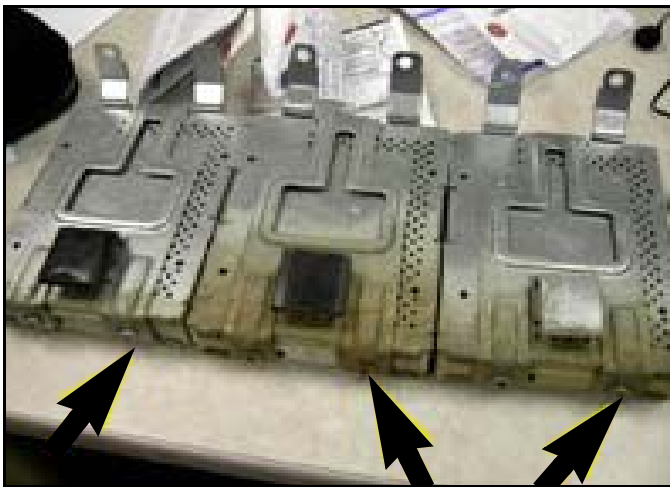
- A). When diagnosing a vehicle with an inoperative XM Set Top Box, check for water intrusion into the set top box.

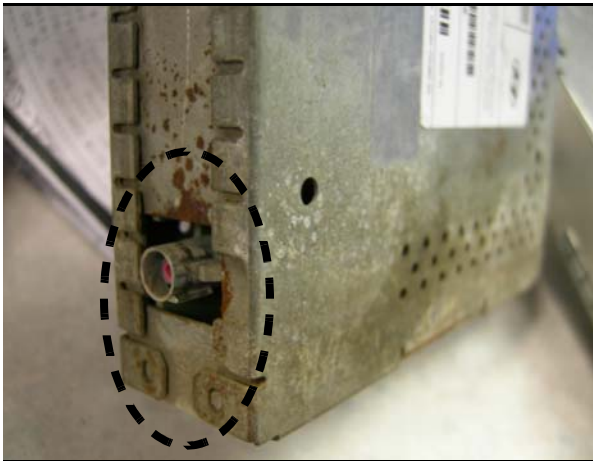
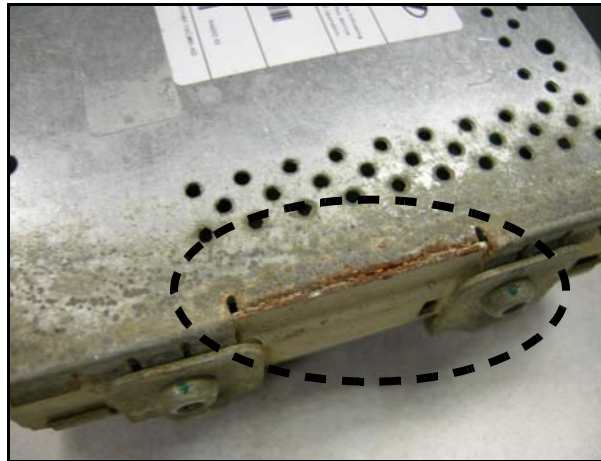
Visible signs of water intrusion are normally at the bottom of the Set Top Box.

If no water damage is noted proceed with normal diagnostics. If water damage is noted then proceed to Step B.

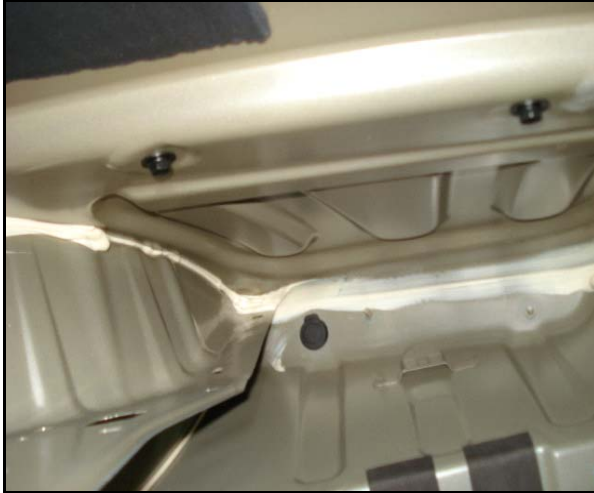
Without Sunroof or AMP

2. Visually inspect body for signs of water intrusion.

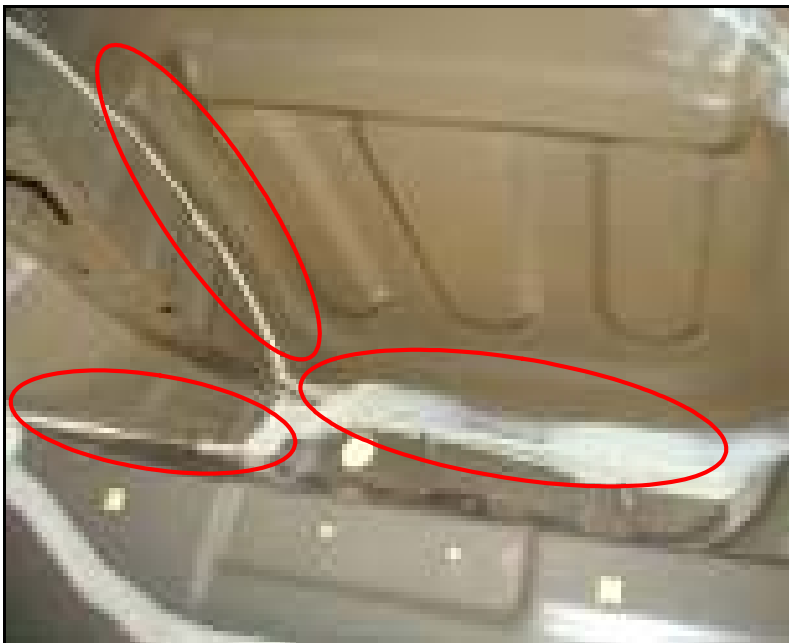
3. Note that water may enter at body seams, screw holes, body plugs, or weld joints.
4. Reseal all joints and any other suspect water entry point with appropriate body sealer sealant.

These joints must
be resealed.
