HYUNDAI Technical Service Bulletin

Group	BODY
Number	08-BD-007
Date	SEPTEMBER, 2008
Model	2006-2009 SONATA

Subject
MANUAL DRIVER'S SEAT HEIGHT ADJUSTER PIVOT LUBRICATION PROCEDURE

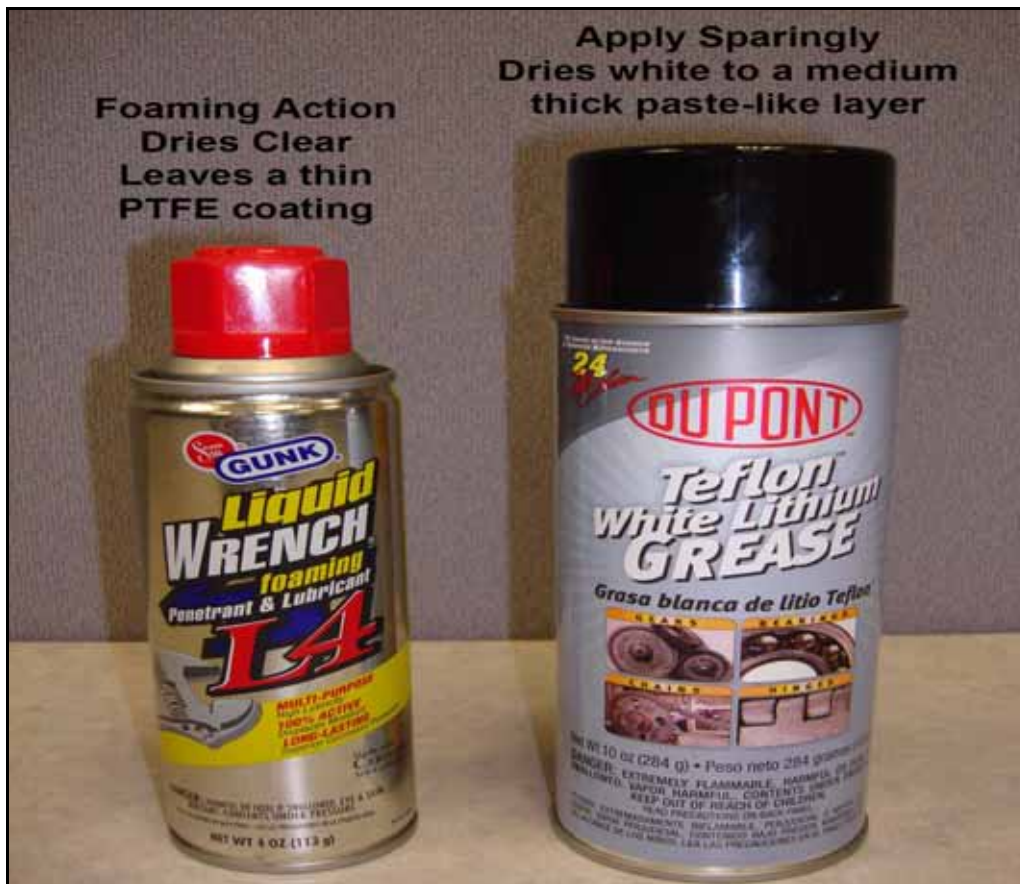
- The two products shown below are available locally at most home improvement stores.

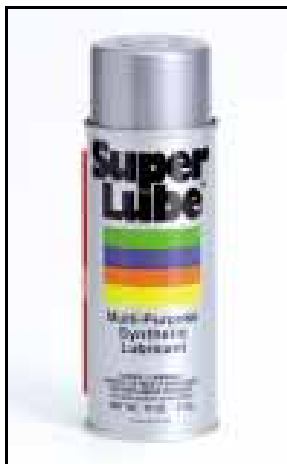
- The Super Lube® Multi-Purpose Aerosol shown below can be ordered online through www.super-lube.com or at select specialty stores.

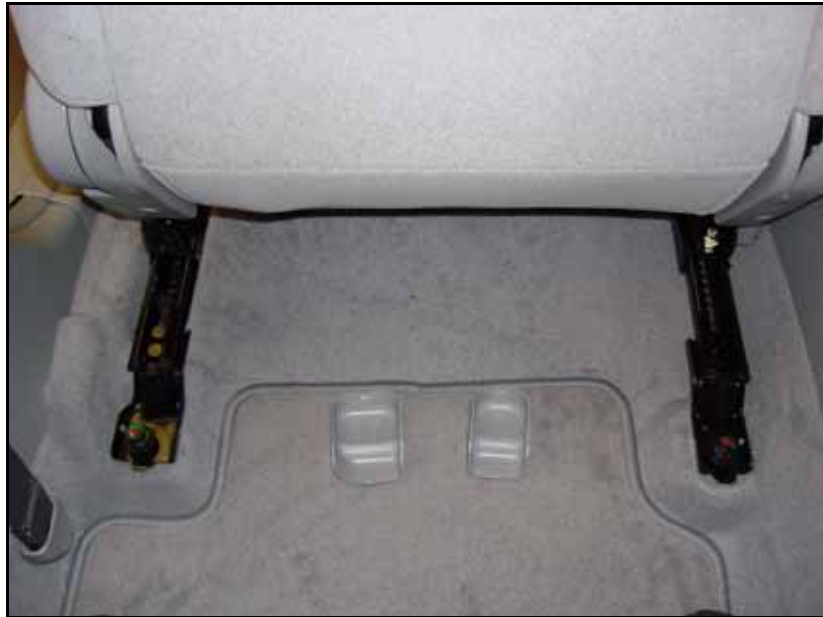
1. Turn ignition key to the OFF position and remove key from cylinder.
2. Slide the driver's seat forward and tilt the seat back slightly forward.
3. Carefully remove the seat track rear fastener covers and fully loosen the two rear mounting bolts.

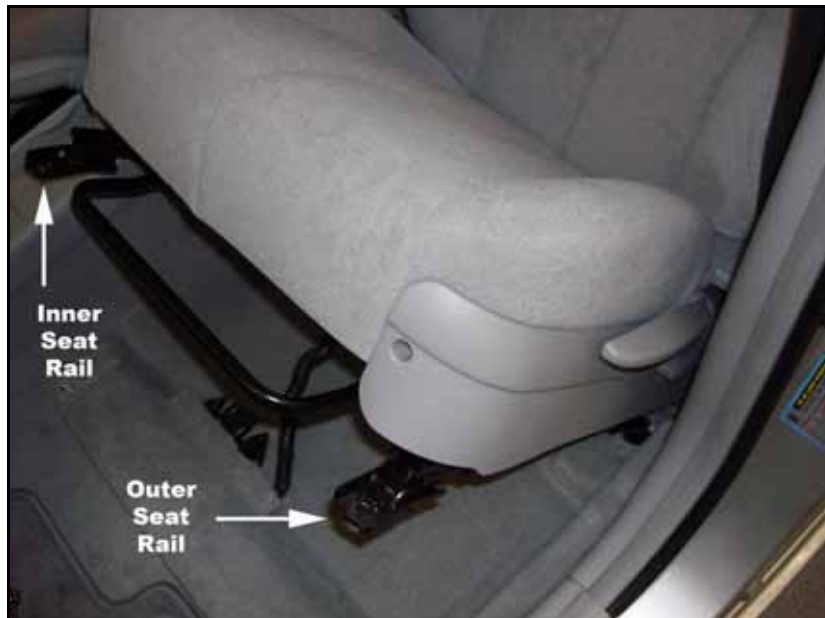
4. Slide the driver's seat fully rearward and remove the seat track front fastener covers.

5. Loosen and remove the two front mounting nuts and carefully pivot the entire seat assembly rearward.

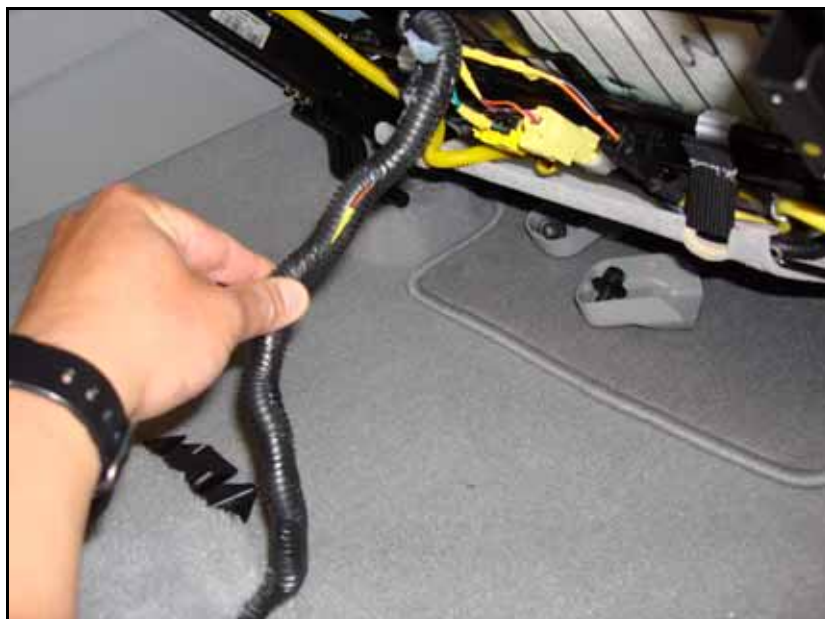
NOTE: Check for slack at the floor harness that is routed to the seat while it is pivoted rearward. If there is no slack, adjust the seat back angle so that the harness is not being strained during the work process.

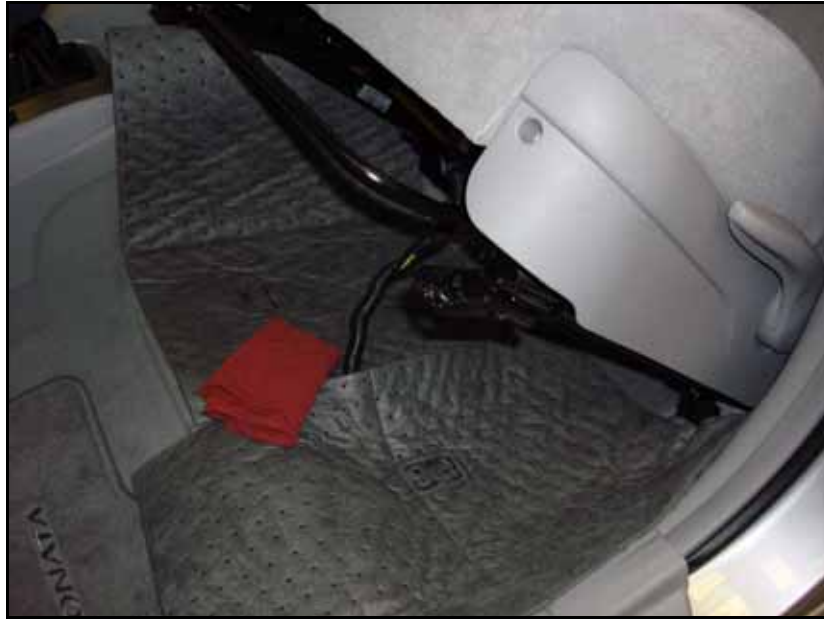
6. Prepare the work area by covering the carpeted surfaces under the seat with absorbent mats and have some clean shop rags within reach to wipe away any excess lubricant.

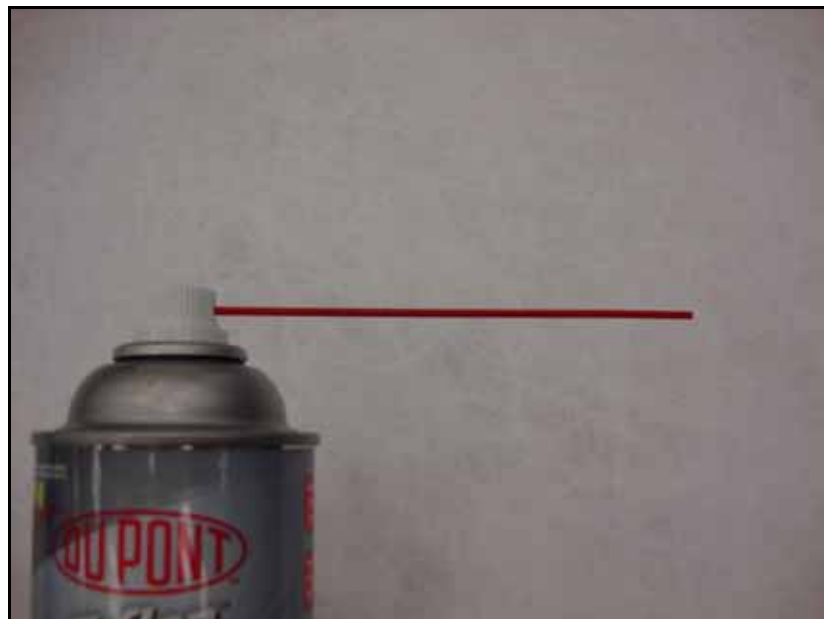
7. Vigorously shake the canister of the lubricant (according to product instructions) to fully mix the contents and then insert the straw applicator to the nozzle.

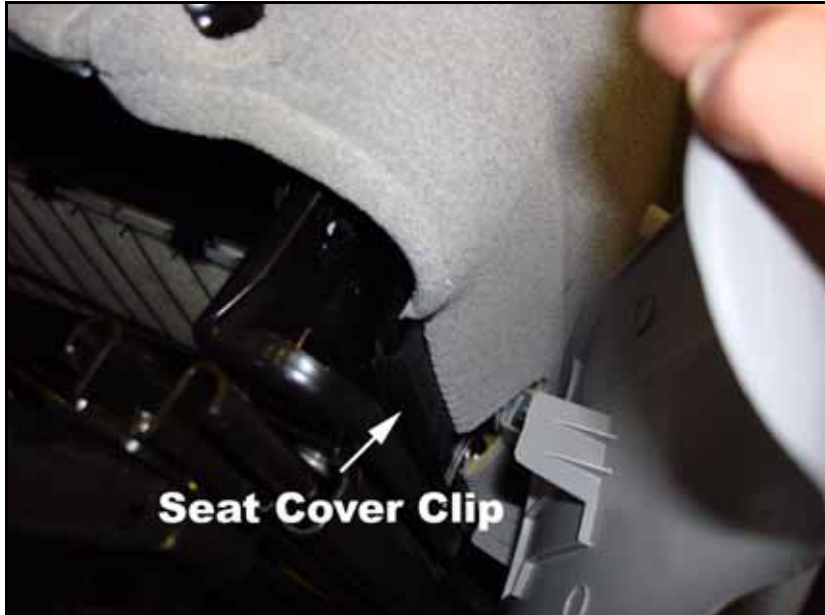
8. Remove the Phillips head screw at the front of the left-hand base cover and pry the cover by hand outward slightly to access the left-hand clip of the seat cover.

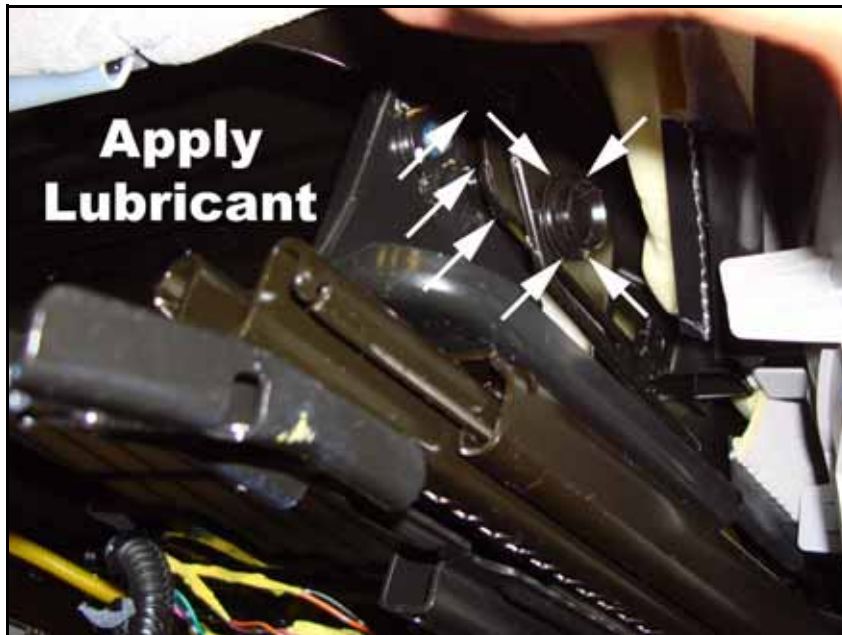
9. After disengaging the left-hand seat cover clip to gain access, lubricate the outside swaged pivot and overlap points above the outer seat rail.

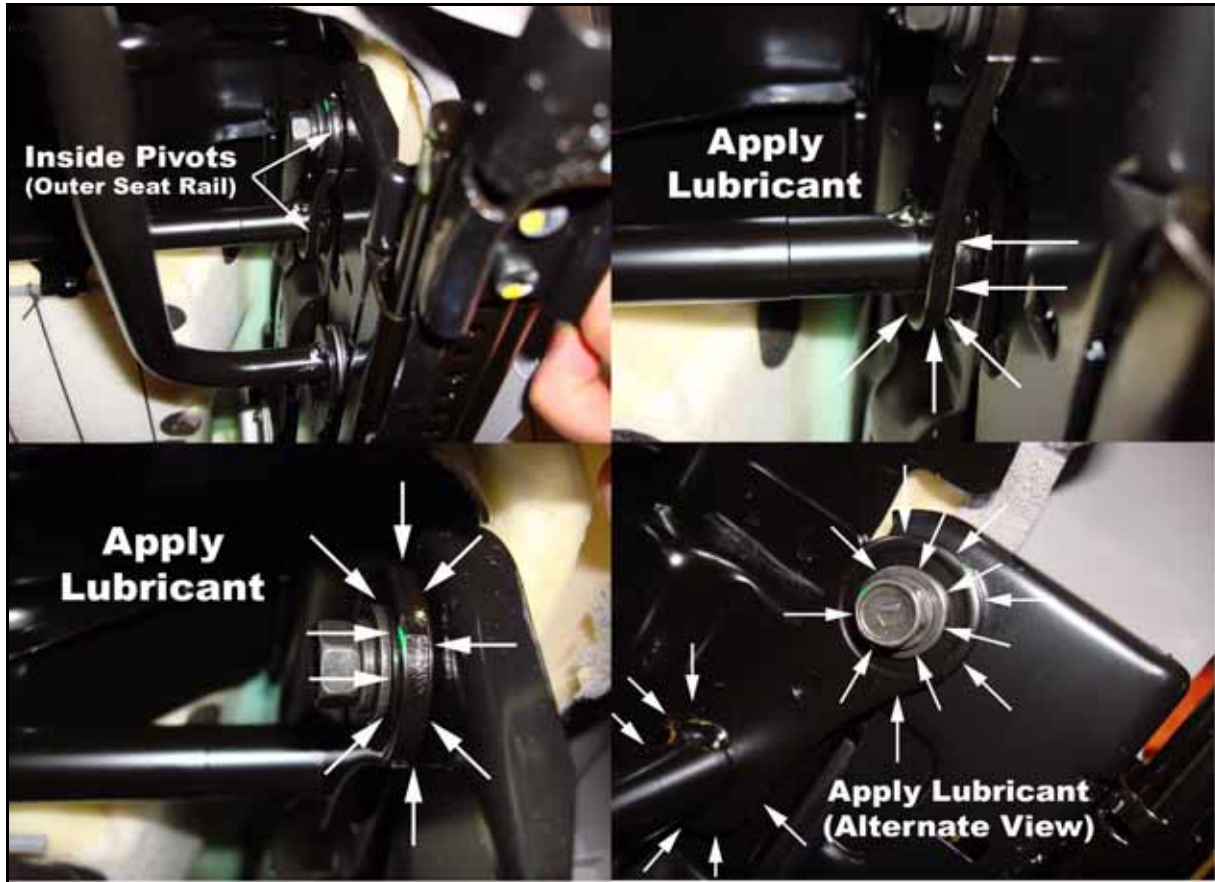
11. Locate and lubricate the inside pivot points above the outer seat rail.

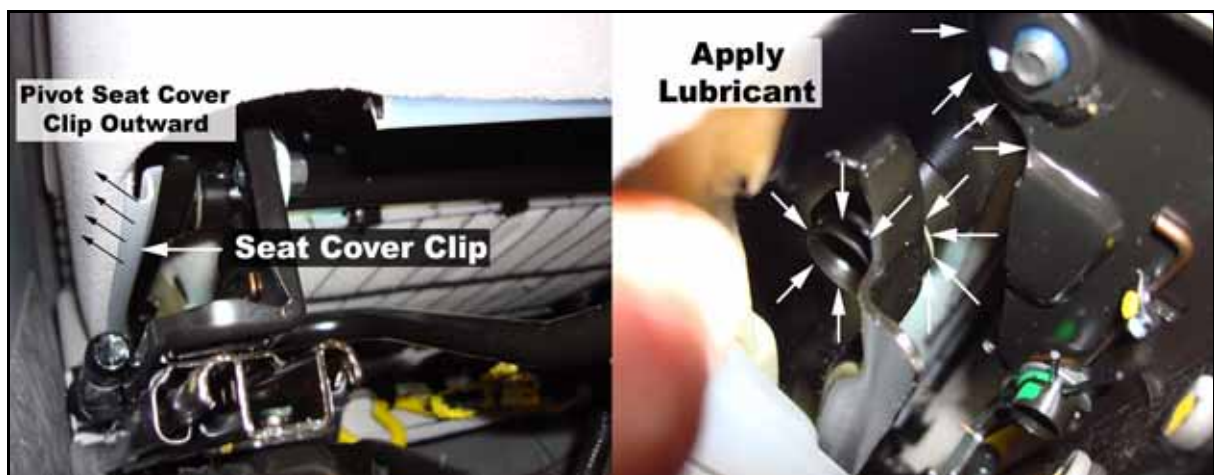
12. After disengaging the right-hand seat cover clip to gain access, lubricate the outside swaged pivot and overlap points above the inner seat rail.

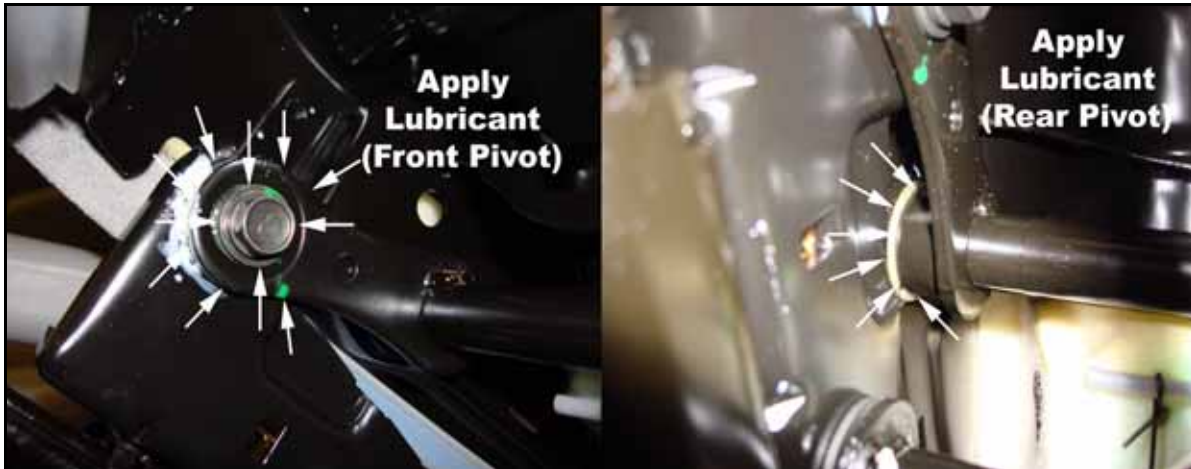
13. Locate and lubricate the inside pivot points above the inner seat rail.

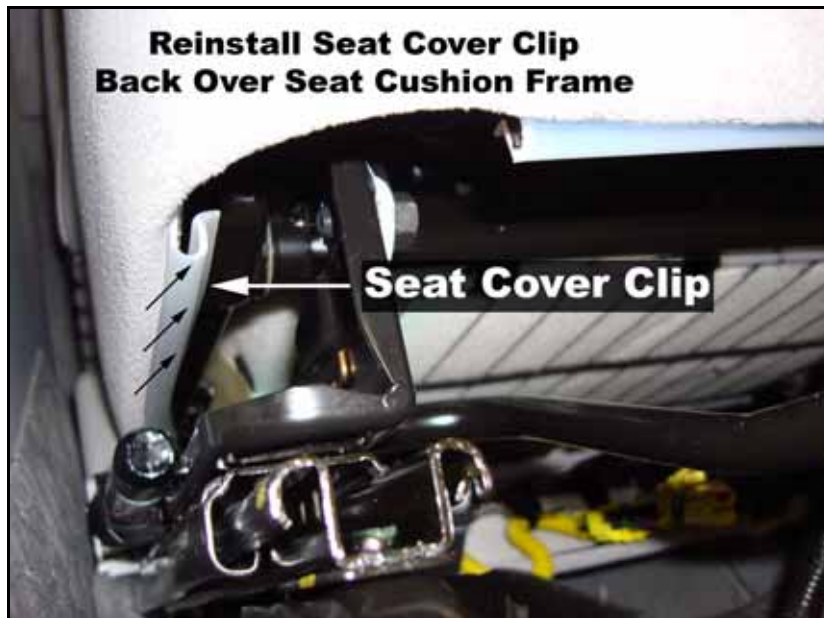
14. Reinstall the seat cover clip by positioning it back over the mounting edge at the bottom of the seat cushion frame.

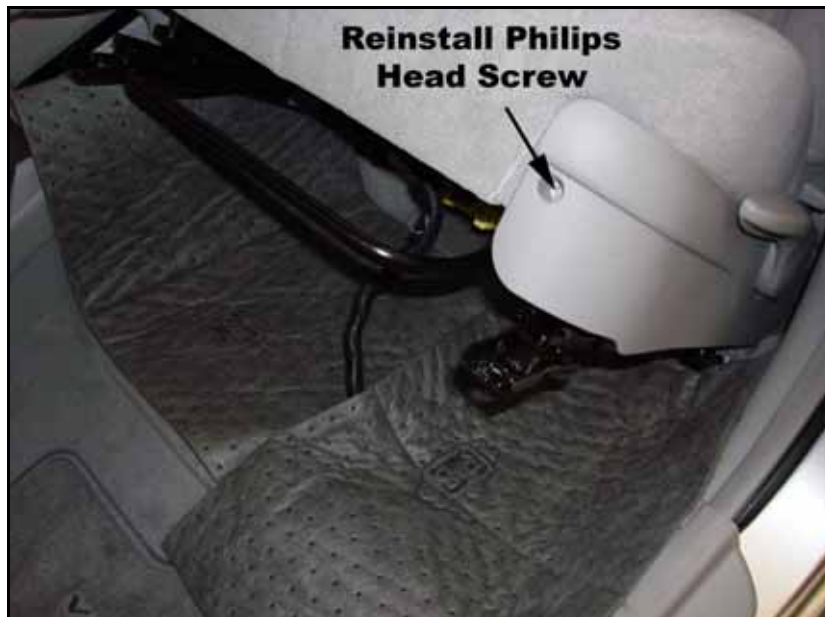
15. Reinstall the Phillips head screw at the front of the left-hand base cover after positioning it back to proper location.

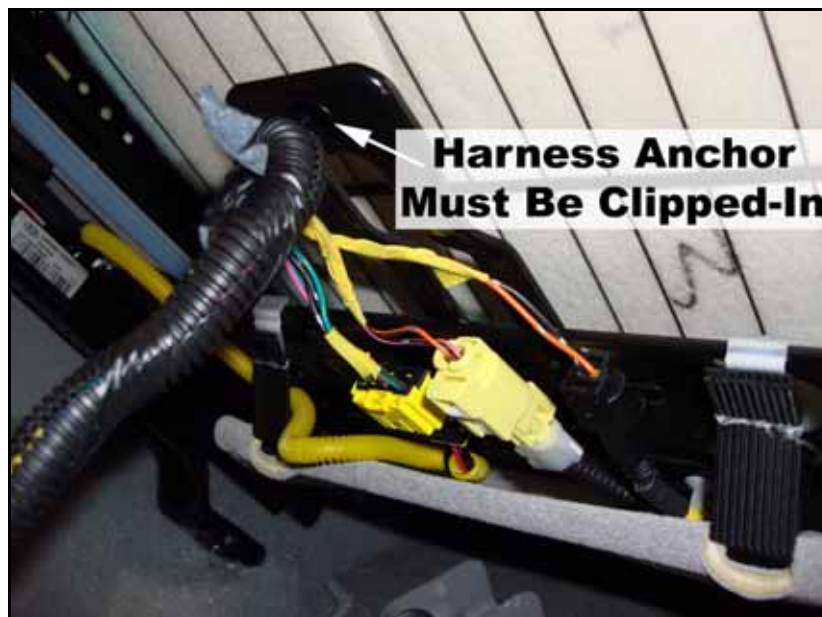
16. Remove protective coverings from the work area and inspect that the harness connections under the seat are still intact.

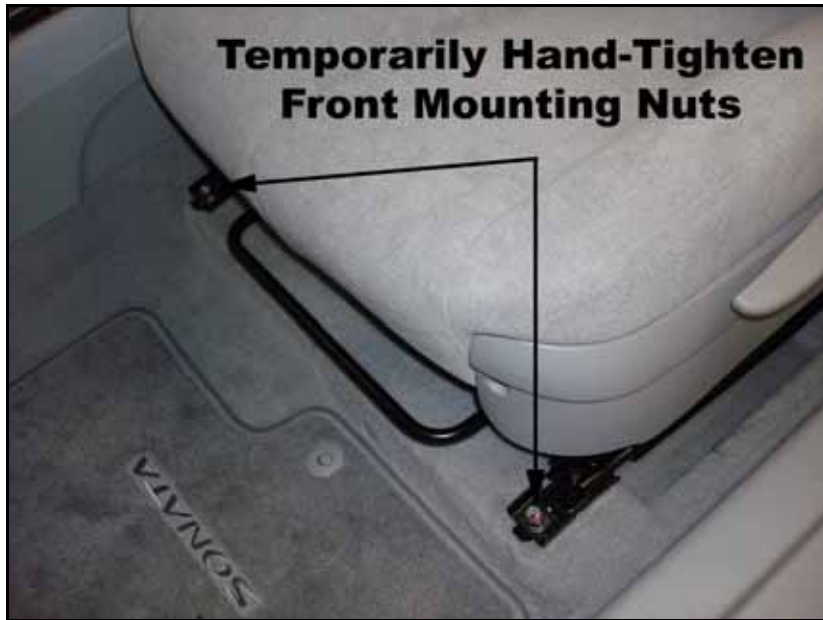
17. Position the front portions of the seat track over the front mounting studs and **HAND-TIGHTEN** the two front mounting nuts (to be wrench-tightened during later step).

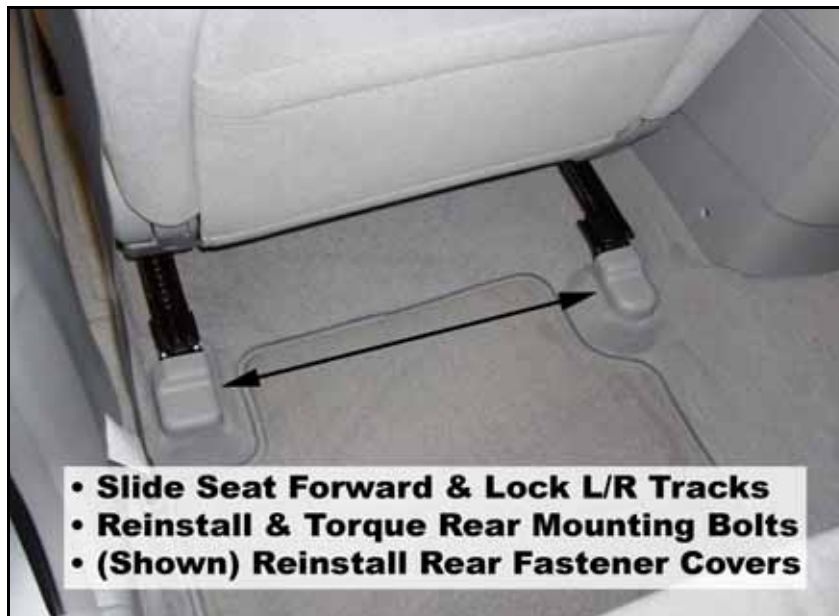
18. Slide seat forward, reinstall the two rear mounting bolts - final torque to 33 lb.ft., and reinstall rear fastener covers.

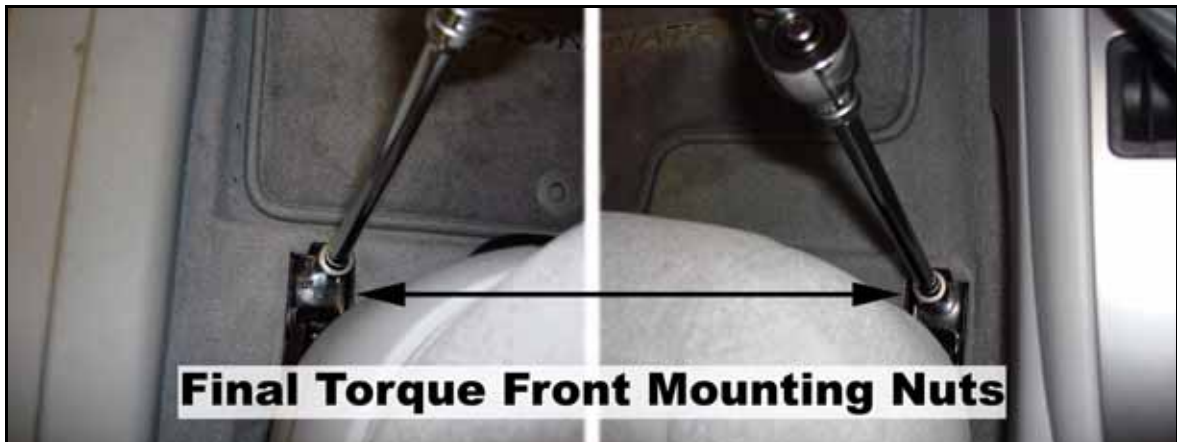
19. Slide seat rearward and final torque the two front mounting nuts to 22 lb.ft.

NOTE: Be sure to fully lock the left and right seat tracks to rails prior to final tightening of the fasteners. If higher than normal amount of effort is required to fully lock both sides of the seat tracks to the seat rails, then loosen all (front and rear) seat track to floor fasteners and repeat the process from Step 18.

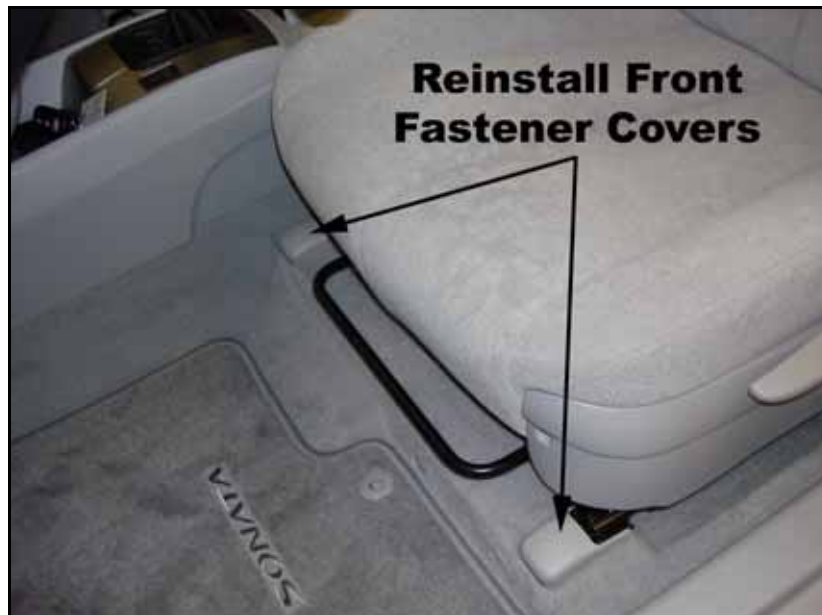
20. Reinstall the front fastener covers.

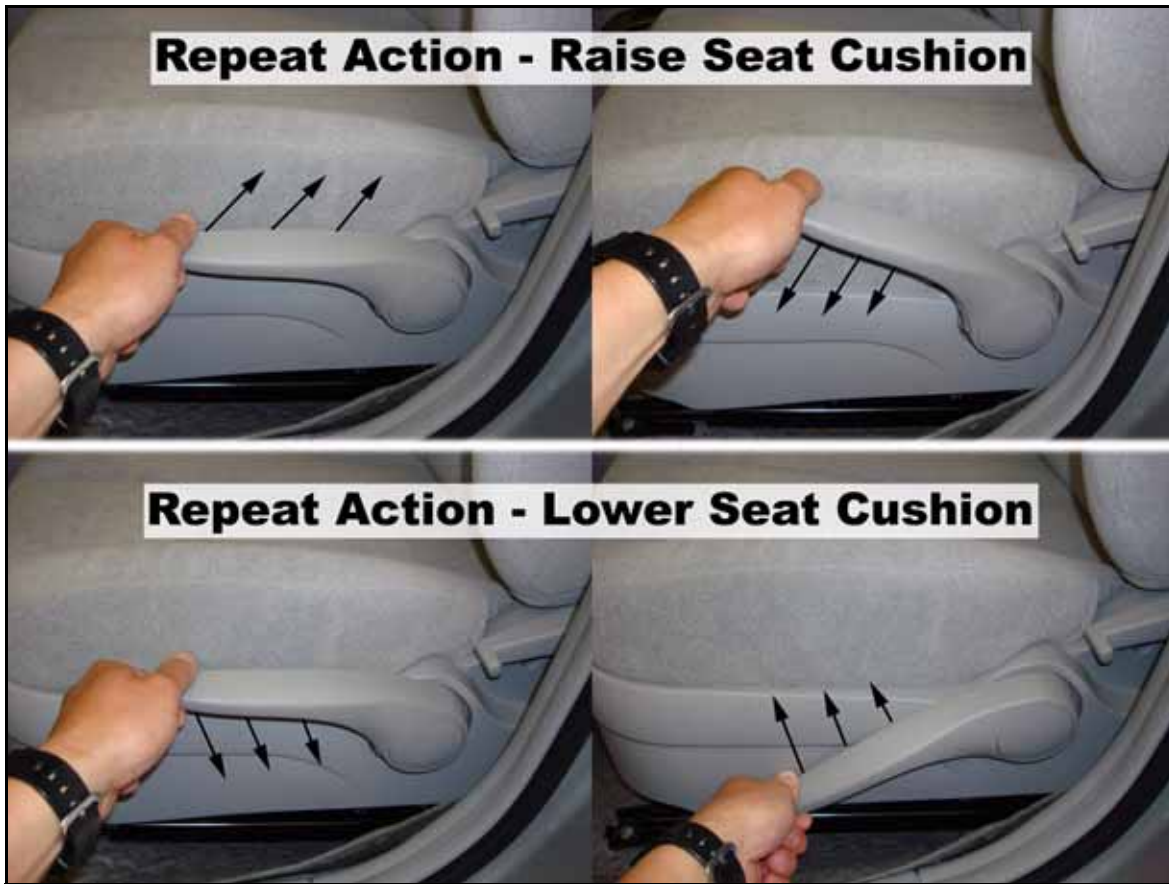
21. Verify repair by raising and lowering the drivers seat cushion height several times while sitting on it.
