HYUNDAI Technical Service Bulletin

Group	TRANSAXLE
Number	05-40-016
Date	OCTOBER, 2005
Model	ALL

AUTOMATIC TRANSAXLE - NO MOVEMENT IN DRIVE OR REVERSE GEAR

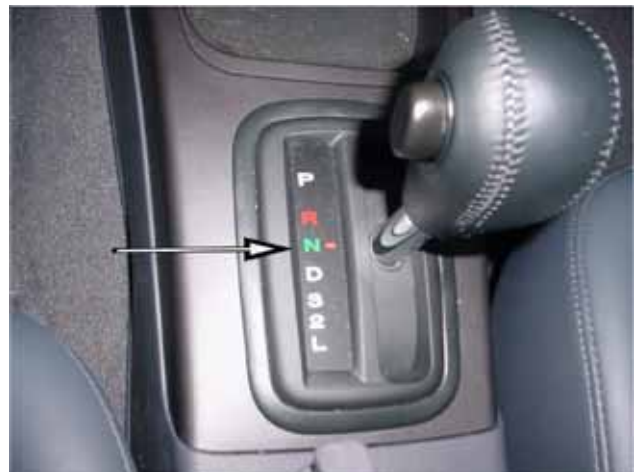
3. Move the shift lever to "N".

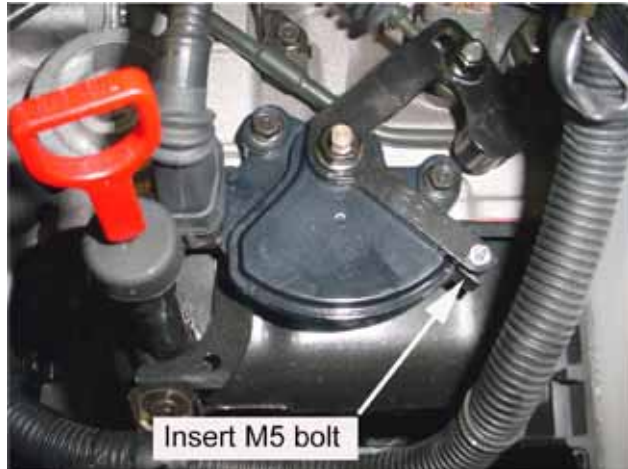
4. Insert a 5 mm drill or M5 (5 mm) bolt in the adjustment hole of the range switch. Check that the drill or bolt fits into the adjustment holes.

- If not, go to Step 5
- If so, go to Step 9

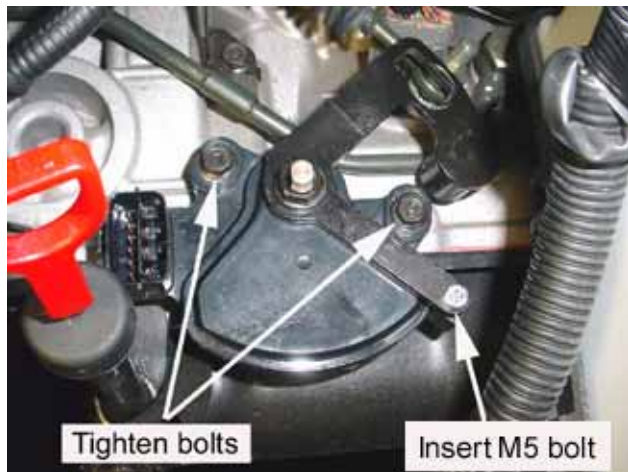
5. Loosen the two 10 mm mounting bolts.
6. Disconnect the shift cable at the lever.
7. Insert a 5 mm drill or M5 (5 mm) bolt in the adjustment hole of the range switch. Tighten the two 10 mm mounting bolts to specification.

Specification: 7-8 ft.lb (10-12 Nm, 100-120 kg.cm)

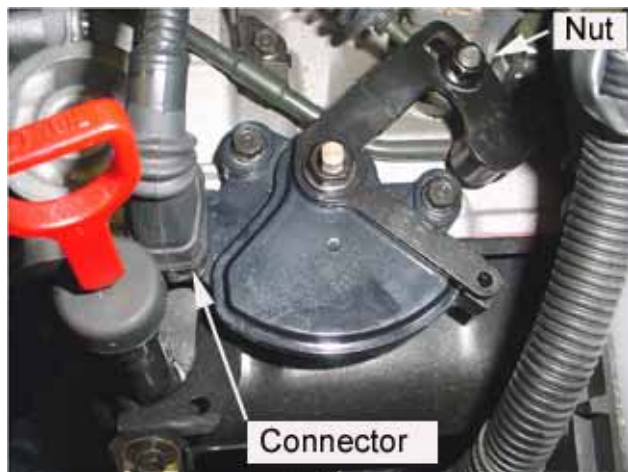
8. Move the shift lever to the "N" position. Attach the shift cable to the lever and install the nut. Tighten the nut to specification.

Specification: 9-10 ft.lb (12-13 Nm, 120-130 kg.cm)

Remove the 5 mm drill or M5 bolt.

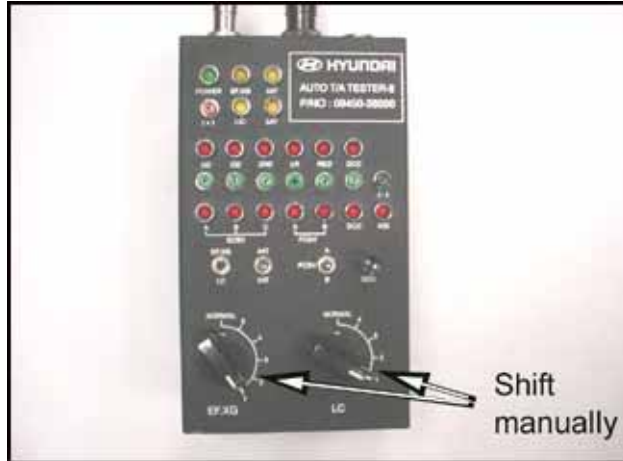
12. Install the A/T Tester, P/N 09450-AT000, to the vehicle:

- Shift the transaxle to “D”. Move the gear selector switch of the A/T Tester and shift manually in 1, 2, 3, 4, and 5 gears (if equipped).

NOTE: Use the “EF, XG” switch for side-pan transaxles and the “LC” switch for bottom-pan transaxles.

- Disconnect the A/T Tester from the solenoid. Do not reconnect the harness connector to the solenoid. Shift the transaxle to “R”.
 - If no movement, replace the transaxle.
 - If the vehicle moves, check the harness connector at the TCM and the solenoid for a bent pin or pin not fully inserted. Check the wiring harness for an open or short circuit.
 - If no problem is found, swap a TCM from a similar vehicle and test for movement in Drive and Reverse. If the vehicle moves in Drive and Reverse, replace the TCM.
