HYUNDAI Technical Service Bulletin

Group	ENGINE ELECTRICAL
Number	05-36-009
Date	AUGUST, 2005
Model	2006 SONATA

Subject
24F BATTERY REPLACEMENT - POSITIVE TERMINAL COVER MODIFICATION

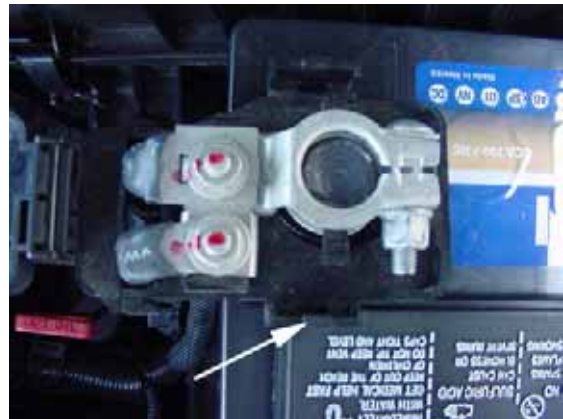
Example shown with Hyundai replacement battery **00275-16000**.

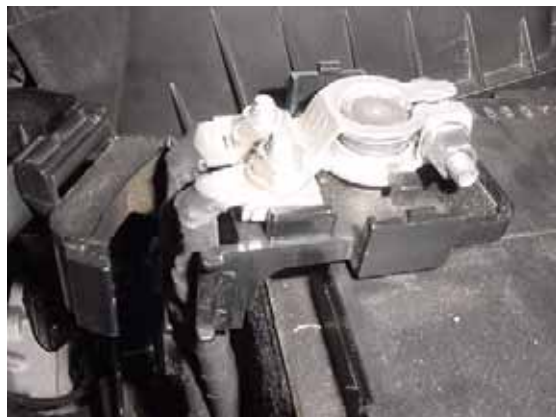
4. Cable stay released.

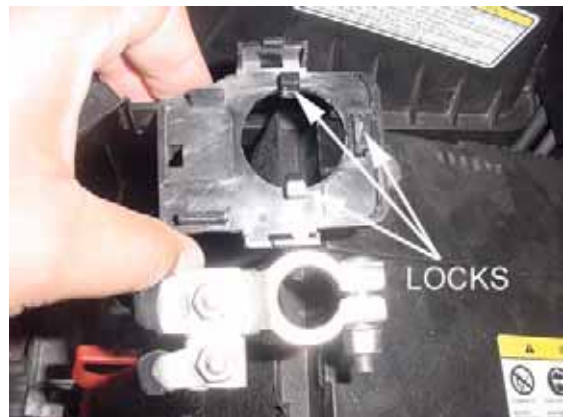
Cover removed from positive cable terminal.

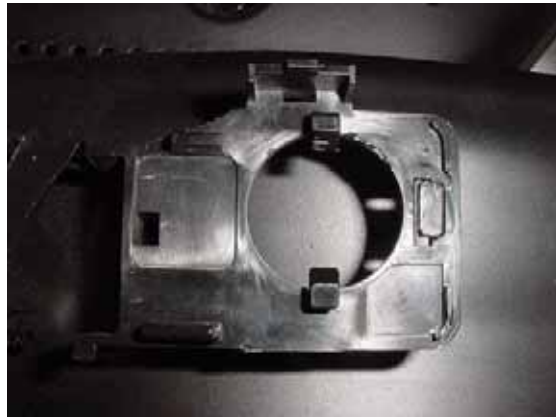
Lower lock tab completely removed.

NOTE: Only one of the lock tabs will now be functional. One lock tab will provide sufficient top cover retention.

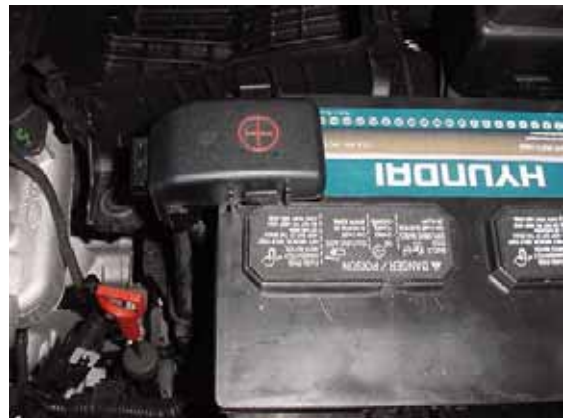
11. The terminal cover should now fit properly between the positive battery post and the raised vent cap.
