HYUNDAI Technical Service Bulletin

Group	BODY ELECTRICAL
Number	08-BE-005
Date	JULY, 2008
Model	2006 SONATA

Subject	STOP LAMP SWITCH ADJUSTMENT
---------	------------------------------------

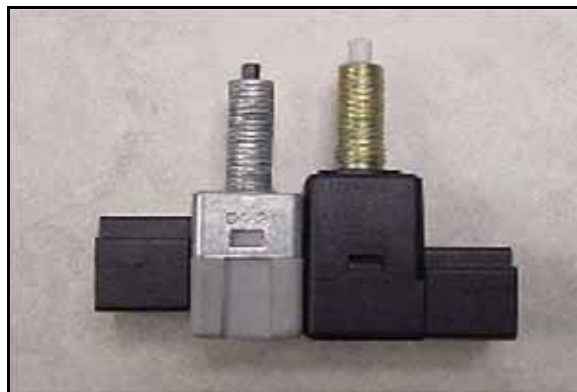
NOTE: Two stop lamp switches have been installed on 2006 Sonatas. The switches are interchangeable.

NOTE: Vehicles with a VIN starting with 5NPEU produced before 8/19/05 have a metal housing (left), vehicles produced on or after 8/19/05 have a plastic housing (right).

NOTE: Vehicles with a VIN starting with KMHET produced before 4/28/05 have a metal housing (left), vehicles produced on or after 4/28/05 have a plastic housing (right).

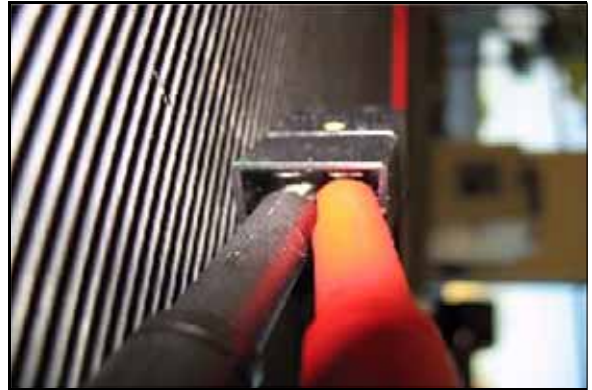
6. Check the continuity of the stop lamp switch by connecting the multimeter to the upper contacts.

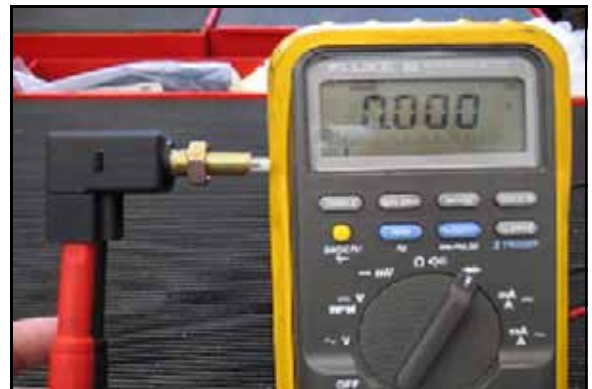
7. With the plunger not depressed, the meter should read approximately 0 ohms, has continuity.

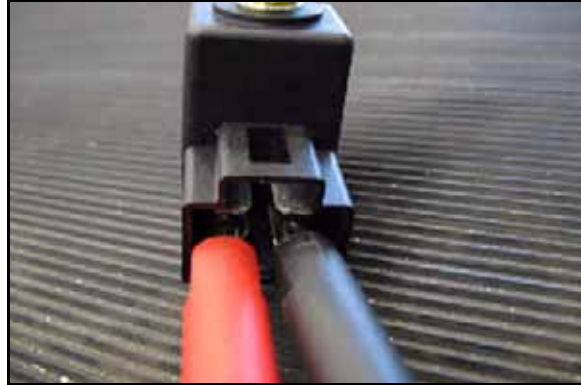
9. Connect the multimeter connectors to the lower contacts on the stop lamp switch.

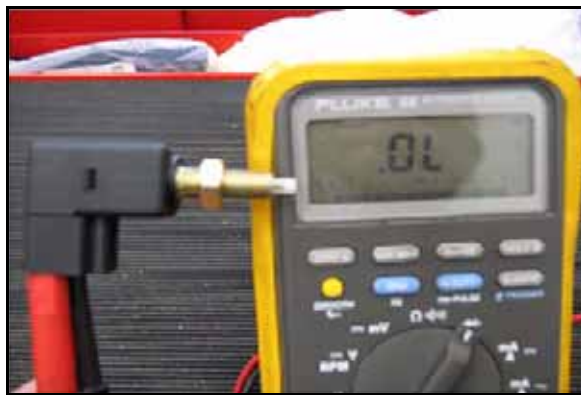
10. With the plunger not depressed, the meter should read open circuit (no continuity).

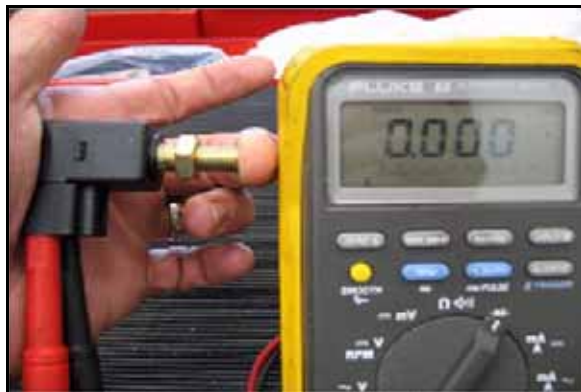
11. Depress the stop lamp switch plunger. Multi meter should read approximately 0 ohms, has continuity.

12. If the stop lamp switch does not pass the continuity test, replace the stop lamp switch.
13. If the stop lamp switch does pass the continuity test, recheck the brake pedal stopper to stop lamp switch clearance or follow the shop manual ETM to diagnose wiring.
