# HYUNDAI Technical Service Bulletin

Group	TRANSAXLE
Number	07-40-016
Date	NOVEMBER, 2007
Model	1999~ SONATA, 2001~ ELANTRA, SANTA FE & XG, 2003~ TIBURON, 2005~TUCSON, 2006~ AZERA, 2007~ ENTOURAGE

**AUTOMATIC TRANSAXLE DIAGNOSTIC TROUBLE CODES P0715, P0716, P0717, P0720, P0721 & P0722**

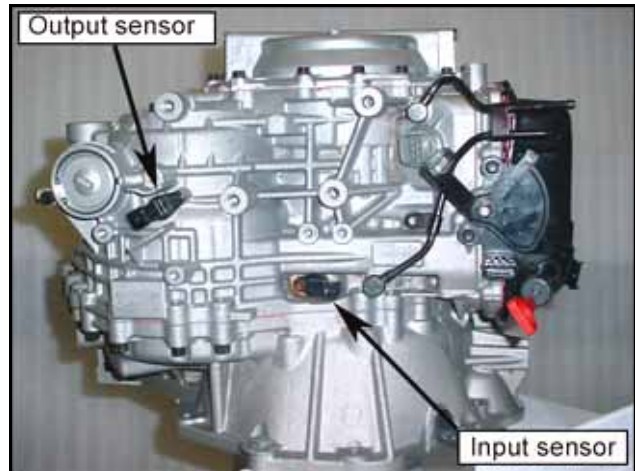
An improperly functioning input speed sensor or output speed sensor may result in the following conditions:

- “Check Engine” light on
- Harsh P-R or P-D engagement shock
- Transaxle in 3rd gear fail-safe
- Diagnostic trouble codes shown on Page 2
