HYUNDAI Technical Service Bulletin

Group	TRANSAXLE
Number	06-40-013
Date	SEPTEMBER, 2006
Model	2001~ SANTA FE & XG, 2002~ SONATA, 2003~ TIBURON, 2005~ TUCSON, 2006~ AZERA

Subject
AUTOMATIC TRANSAXLE “SHIFTRONIC” DIAGNOSIS

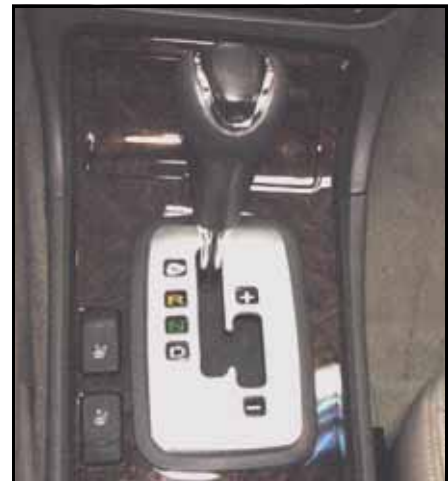
If you are servicing a vehicle equipped with a “SHIFTRONIC™” automatic transaxle that has the following symptoms, refer to the repair procedure shown below:

- Will not shift in “D” position, but shifts correctly in “Sports Mode”
- Will not upshift or downshift in “Sports Mode”
