# HYUNDAI Technical Service Bulletin

Group	TRANSAXLE
Number	06-01-003
Date	MAY, 2006
Model	SONATA

Subject  
**2006 SONATA 3.3L PCM REPROGRAMMING  
 INSTRUCTIONS FOR REDUCING DOWNSHIFT TIME  
 (CAMPAIGN T15)**

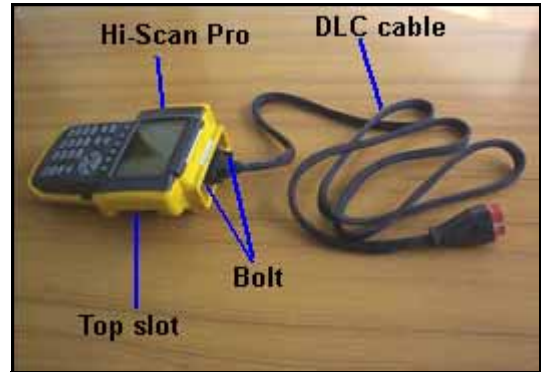
1. Attach the Data Link Connector (DLC) cable to the Hi-Scan Pro main body and securely tighten the two bolts.
2. Remove the system software card from the Hi-ScanPro and insert the black 32 MB reprogramming software card into the Hi-Scan top slot.
3. Connect the DLC cable from the Hi-Scan Pro into the data link connector (16 Pin connector).

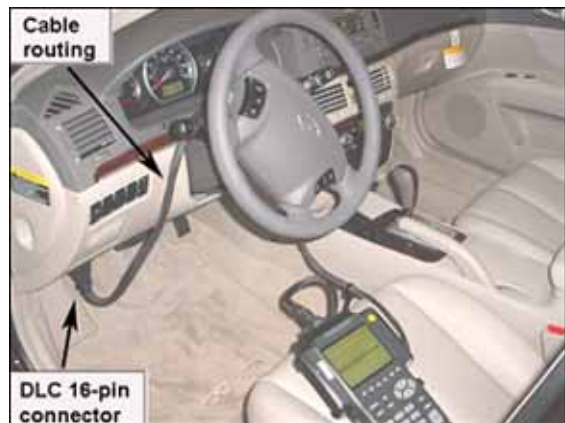
**NOTE:** Route the cable over the steering column to ensure the cable does not become disconnected.

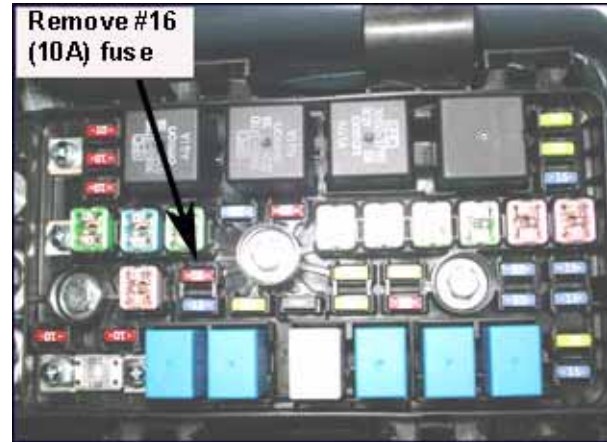
1. Turn the ignition switch to the OFF position.
2. **Pull out the ECU fuse #16 (10A) from the engine room relay box for 15 seconds and then reinstall it.**
3. Turn the ignition switch to the ON position. (Do not start the engine)
4. Turn the Hi-Scan Pro ON and press ENTER.
5. Select option **"70. NF 3.3 DRIVING FEEL IMPROVEMENT"** and press ENTER.
6. Select option **"02. NF 3.3 DRIVING FEEL [ERROR]"** and press ENTER.

7. Select 39110-3C760 and press ENTER.
