HYUNDAI Technical Service Bulletin

Group	CAMPAIGN
Number	08-01-008
Date	JULY, 2008
Model	2009 SONATA

Subject
**ECM UPDATE - 2009 SONATA (NF) 3.3L ROUGH IDLE
 (CAMPAIGN T53)**

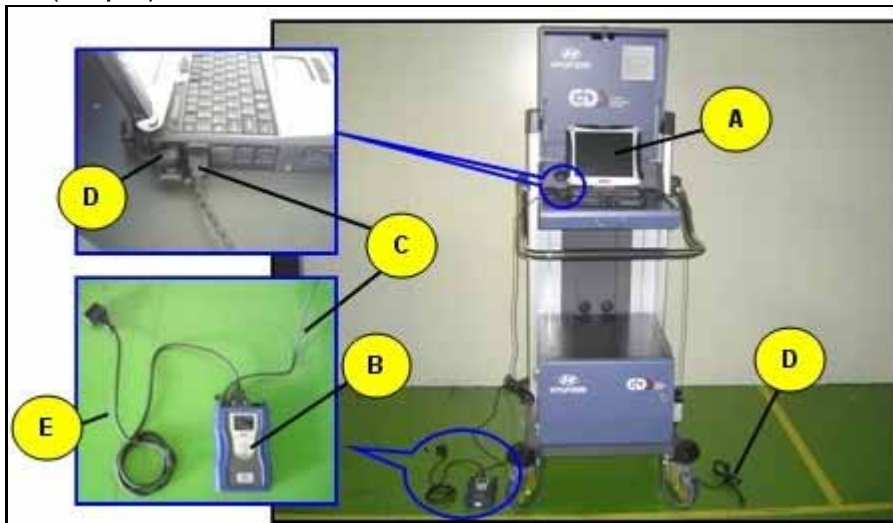
D: Power supply cable

E: DLC cable (16-pin)

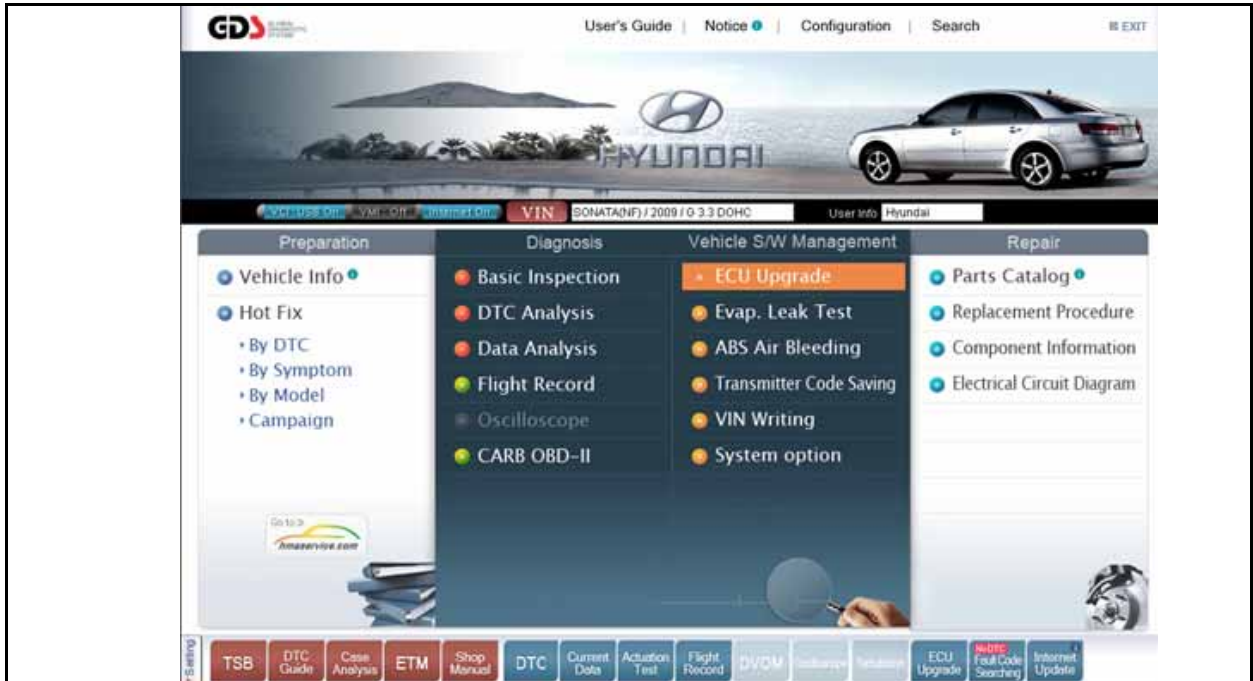
c. Select ECU Upgrade on the initial screen after entering the vehicle information.

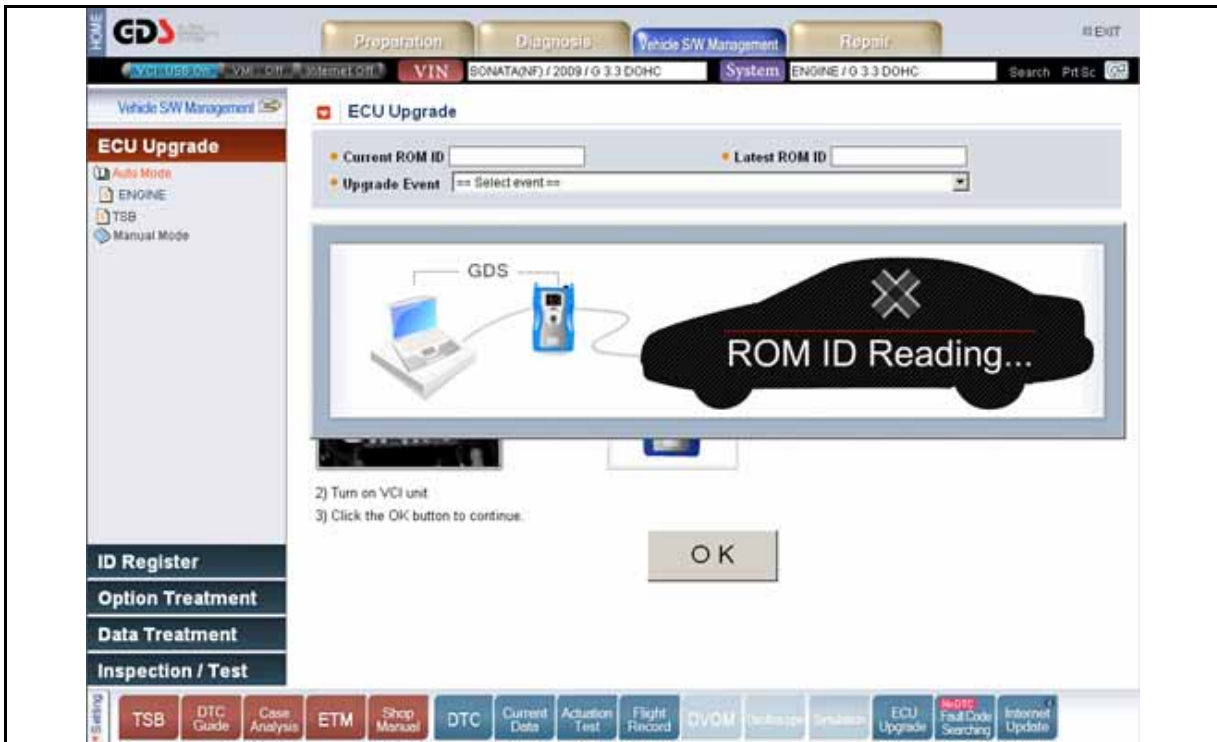
e. Read Preparation and click OK.

f. The GDS will read the vehicle's ROM ID.

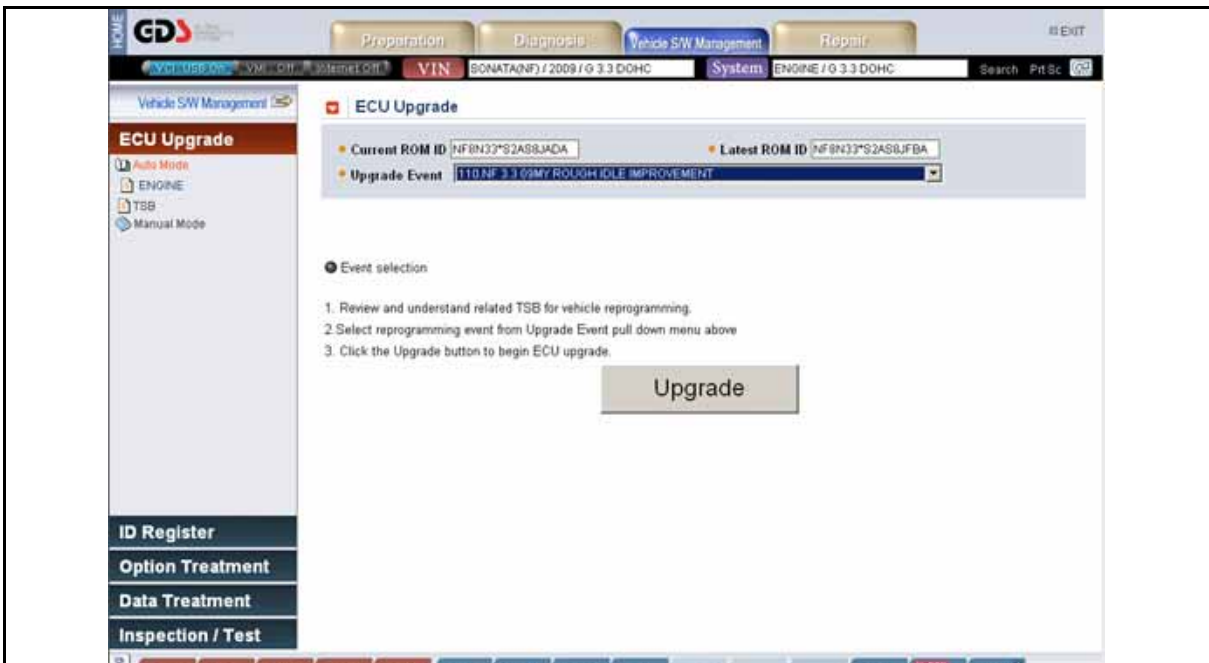
g. After the Current ROM ID is displayed, select the Upgrade Event, "110. NF 3.3 09MY ROUGH IDLE IMPROVEMENT."

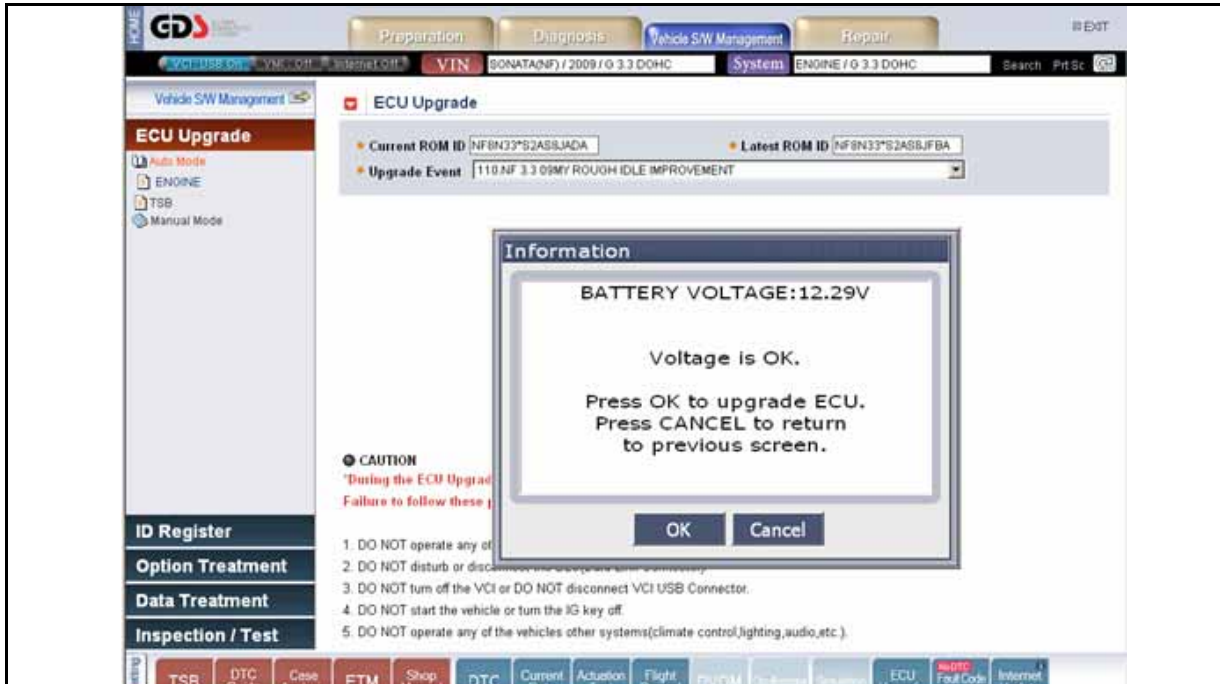
- i. The vehicle battery voltage is checked to make sure it is at least 12 volts to assure reliable update results. Click OK if the results indicate Voltage is OK.

NOTE: If voltage is below 12 volts, click Cancel and then run the engine to assure an adequate battery charge state for reliable update results.

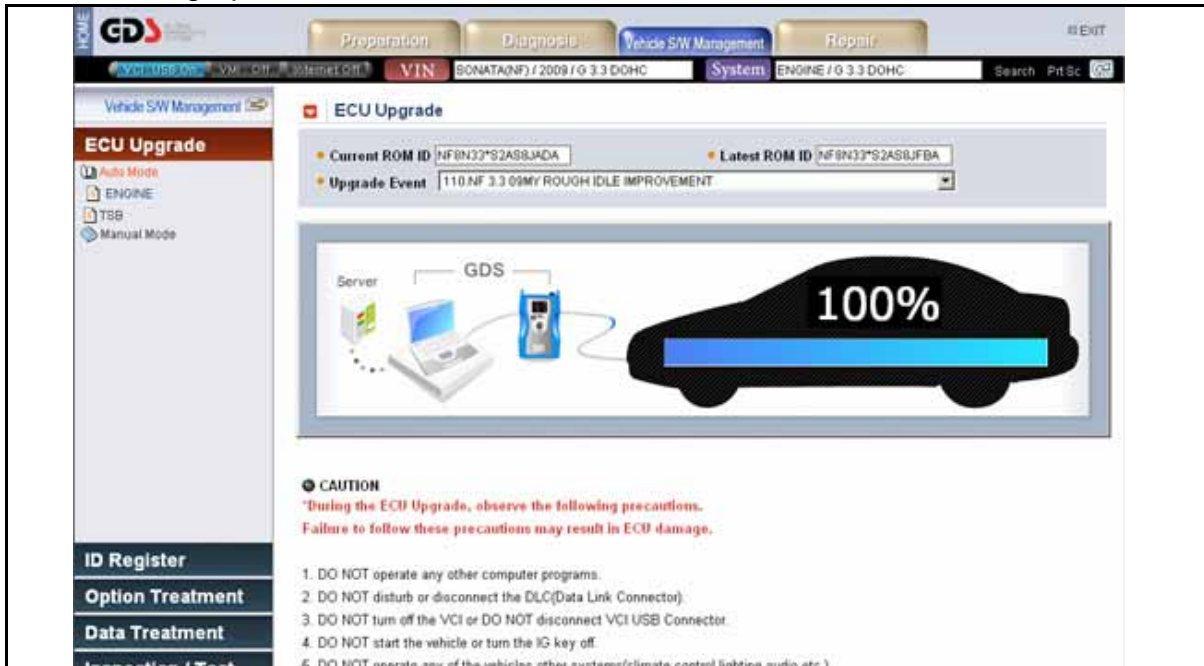
- j. Update will begin and the progress of the update will appear on the bar graph.

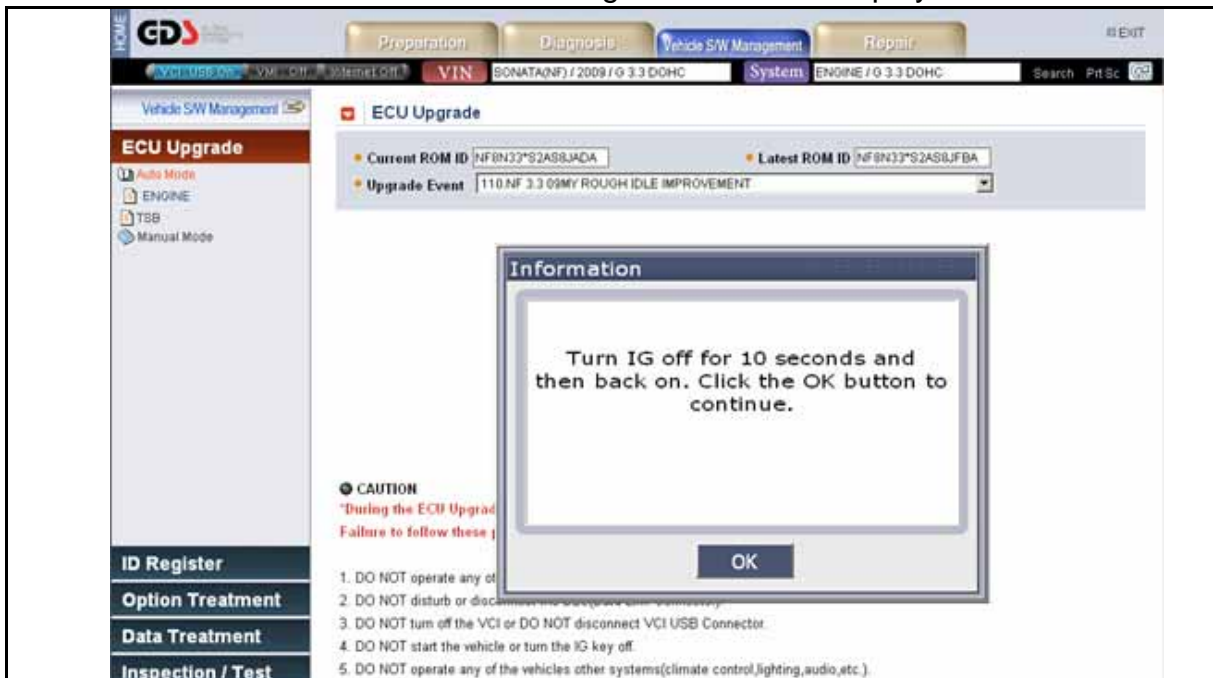
- k. Update will occur until 100% is reached on the bar graph. Turn the ignition key OFF for 10 seconds, place it back in the ON position and then click OK to continue according to information displayed on the screen.

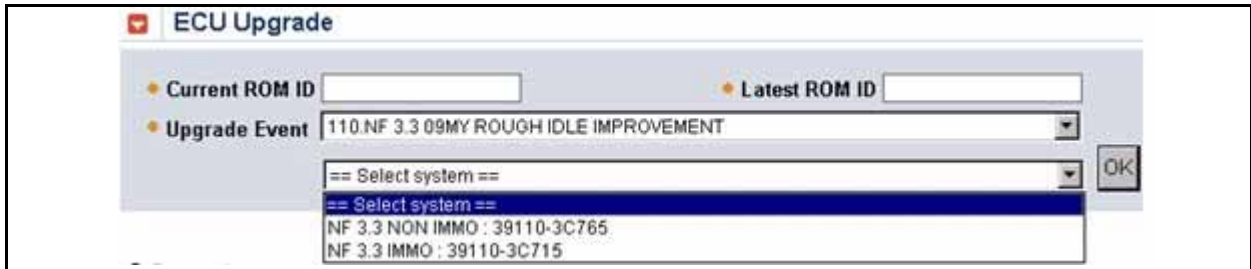
- a. Within the ECU Upgrade screen, select Manual Mode in the left column, then select Upgrade Event #110. Select the system as NF 3.3 NON IMMO : 39110-3C765 and click OK.
