HYUNDAI Technical Service Bulletin

Group	AUTOMATIC TRANSMISSION
Number	08-AT-002
Date	APRIL, 2008
Model	2006~ SONATA, 2006~ AZERA, 2007~ SANTA FE, 2007~ VERACRUZ, 2009~ GENESIS

Subject
**AUTOMATIC TRANSMISSION SHIFT KNOB
REPLACEMENT PROCEDURE**

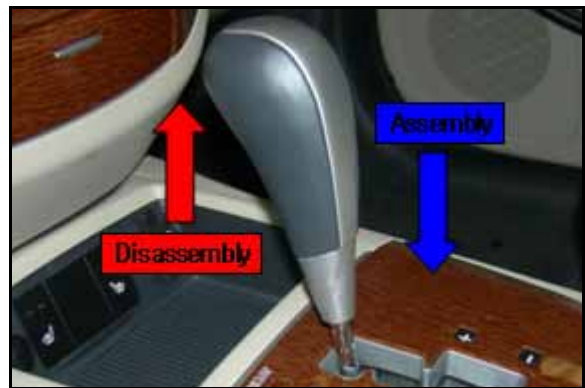
1. Engage the parking brake and put the transmission in neutral.
2. Pull up on the shift knob to disengage the snap ring (A) and remove the shift knob.

NOTE: An upward force of 50 lbs may be required to remove the knob.

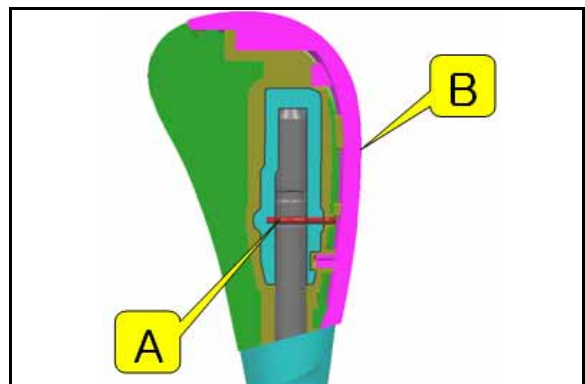
3. Push down on the shift knob to install.

NOTE: It is not necessary to remove the decorative plastic cover (B) to access the snap ring (A). Removing this cover may damage to the shift lever.

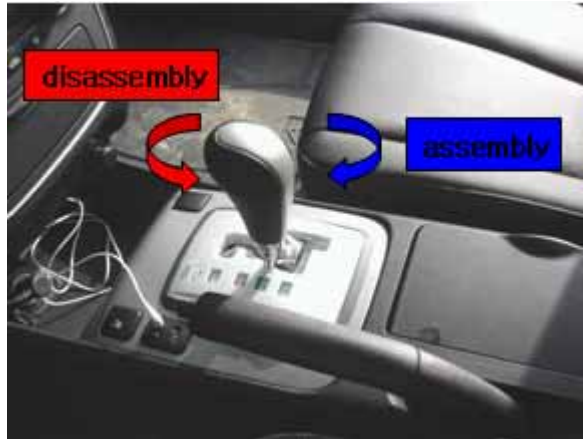
2006~ Sonata:

1. Rotate the shift knob counter-clockwise to remove the knob.
2. Rotate the shift knob clockwise to install.
