HYUNDAI Technical Service Bulletin

Group	TRIM
Number	06-80-001
Date	FEBRUARY, 2006
Model	2006 TUCSON & SONATA

Subject
INSTALLATION OF TIE DOWN PLUGS DURING PDI

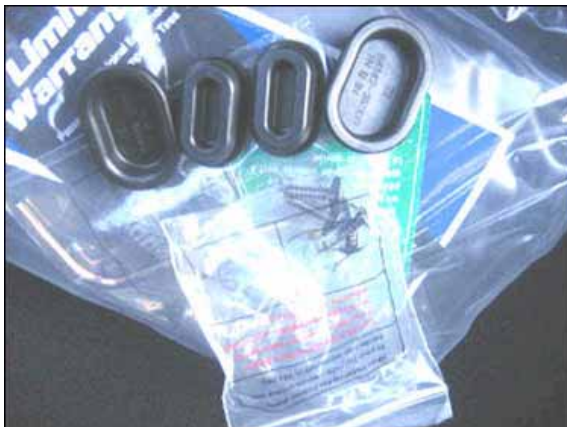
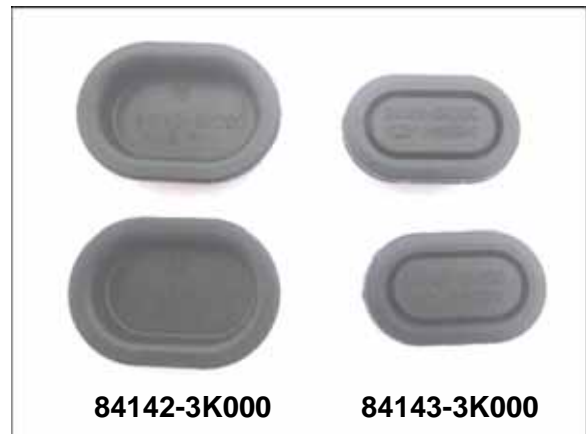
PART NUMBER	DESCRIPTION	MODEL/APPLICATION	PHOTO
84142-3K000	Plug - Front Side Member Drain	Sonata / Front Tucson / Rear

84143-3K000	Plug - Drain	Sonata / Rear

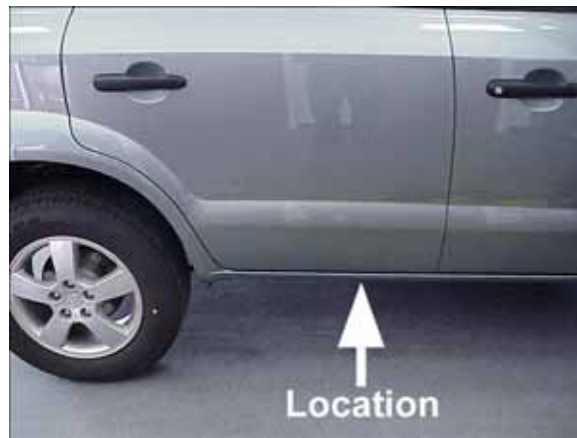
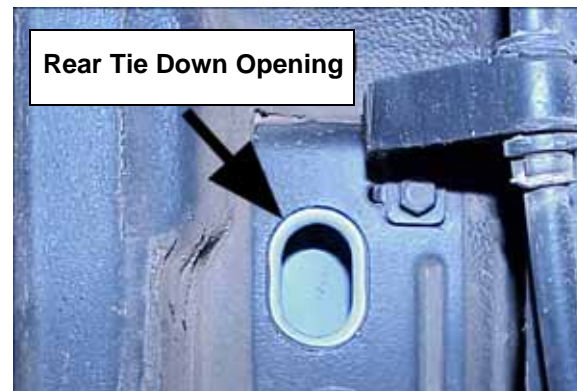
PROCEDURE FOR TUCSON VEHICLE:

1. Locate the tie down locations under the vehicle.

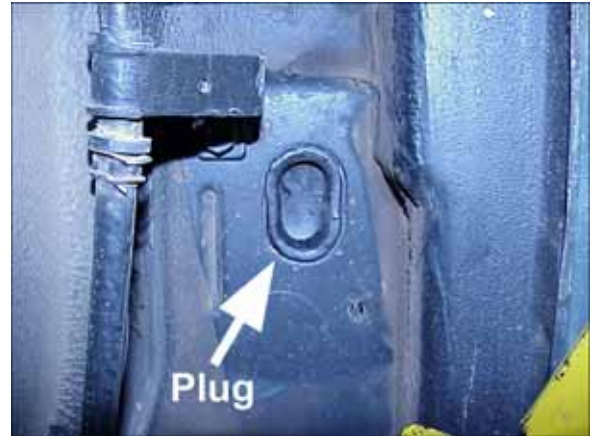
2. Install the plugs to the rear tie down openings.

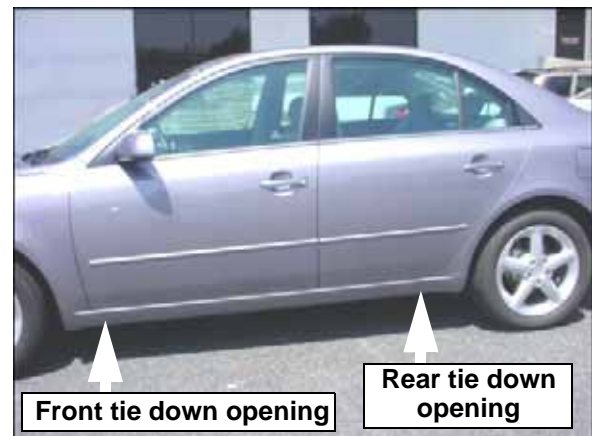
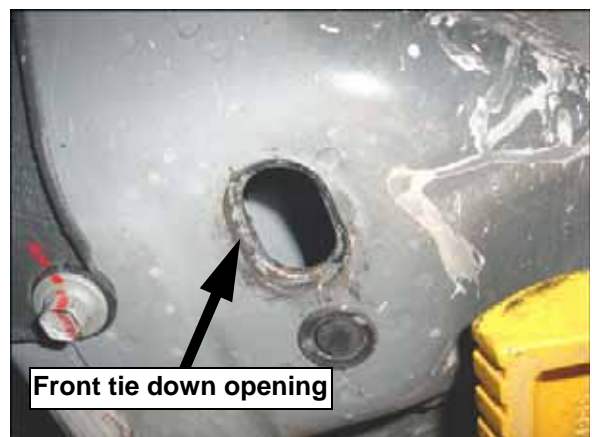
PROCEDURE FOR SONATA VEHICLE:

1. Locate the two front tie down locations under the vehicle.

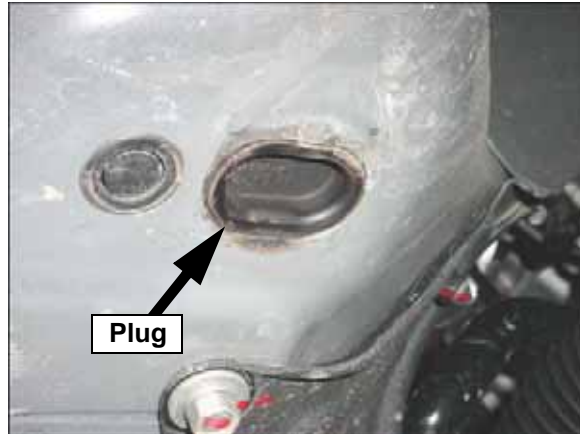
2. Install the plugs into the front tie down openings.

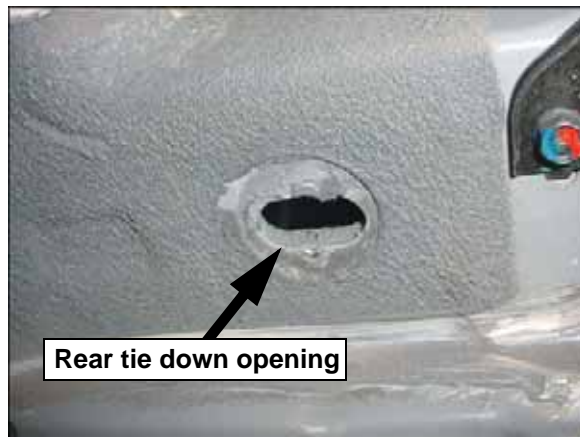
3. Locate the rear tie down locations under the vehicle.
4. Install plugs to the rear tie down openings.
